Access Compliance Report

Public Rights-of-Way

(Curb Ramps)

Intersection ID: N/A	Main Street: PERTH_MOOR_RD	Cross Street: HAMILTON_BRIDGE_RD	Location: SE
ADA ID: C12211ACF4DB	Ramp Type: BlendTrans2	Initial Pass/Fail: Fail	Overall Compliance: No
		Severity Score: 8.75

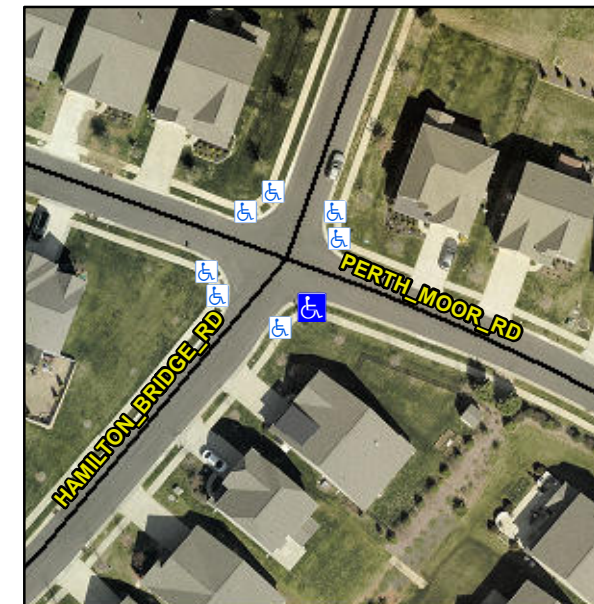
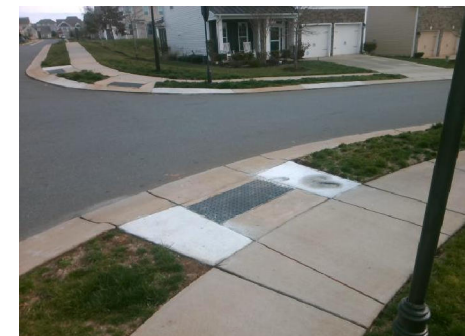
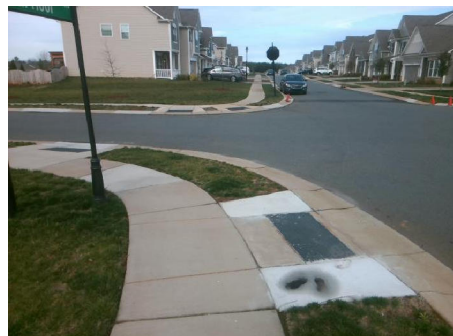
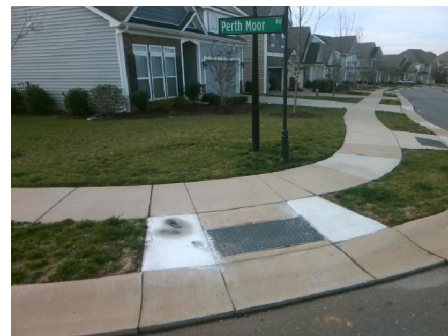
Compliance	Description	Data	Compliance	Description	Data
N/A	Ramp Length (in)	95.0	Yes	BlendTrans Slope (%)	2.1
No	Ramp Width (in)	47.0	Yes	BlendTrans XSlope (%)	1.6
N/A	Flare Type LT	N/A	N/A	Flare Type RT	N/A
N/A	Flare Slope LT (%)	N/A	N/A	Flare Slope RT (%)	N/A
N/A	Flare Traversable LT?	N/A	N/A	Flare Traversable RT?	N/A
N/A	Landing Length (in)	N/A	N/A	DWS Provided?	N/A
N/A	Landing Width (in)	N/A	N/A	DWS Contrast?	N/A
N/A	Landing Slope (%)	N/A	N/A	DWS Length (in)	N/A
N/A	Landing X Slope (%)	N/A	N/A	DWS Full Width?	N/A
N/A	Landing Curb? (Y/N)	N/A	N/A	DWS Offset (in)	N/A
N/A	Shared Landing?	N/A			
N/A	Gutter Ponding?	N/A	N/A	Gutter Slope (%)	N/A
N/A	Gutter Lip Ht (in)	2.0	N/A	Gutter X Slope (%)	N/A
N/A	Painted X Walk1?	No	N/A	Painted X Walk2?	N/A
	X Walk 1 Direction	To NE		X Walk 2 Direction	N/A
	X Walk 1 Width (in)	N/A		X Walk 2 Width (in)	N/A
	X Walk 1 Slope (%)	2.4		X Walk 2 Slope (%)	N/A
	X Walk 1 X Slope (%)	1.8		X Walk 2 X Slope (%)	N/A

N/A	Ramp inside XWalk1?	N/A	N/A	Ramp inside XWalk2?	N/A
	Road Slope (%)	1.8		Clear Space?	N/A
	Road X Slope (%)	2.4	N/A	Clear Space to XWalk (in)	N/A
N/A	Any Obstructions?	N/A	N/A	Storm Grate/Utility Hazard?	N/A
	Obstruction Type			Storm Grate/Utility Type	
		N/A			N/A
			Yes	Surface Condition? (G/P)	Good
			N/A	Curb Slope (%)	0.1

Remove & Replace Curb Ramp With Two New Directional Ramps or Equivalent.

R304.5.1
