Access Compliance Report Public Rights-of-Way (Curb Ramps)

Main Street: FREEDOM DR Intersection ID: 11794 Cross Street: THRIFT RD Location: NW Initial Pass/Fail: Fail **Overall Compliance: No** 12.5 ADA ID: C12FB8C24CB4 Ramp Type: Combination1 **Severity Score:**

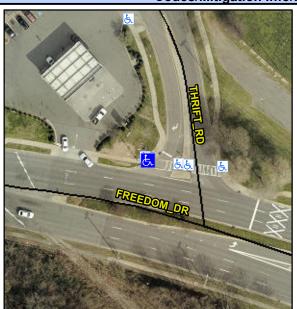
Street 1 Name StopSign THRIFT RD Stop Condition-Street 1 Street 2 Name N/A Stop Condition-Street 2 N/A Possible Solutions: Compliance Description N/A Remove & Replace Entire Ramp. Remove & Replace Sidewalk. Yes Yes No N/A Yes Surveyor Notes: N/A **RT RP < 5%** N/A N/A N/A N/A PROW/ADA: N/A R304.5.3 N/A N/A N/A
