## **Access Compliance Report Public Rights-of-Way** (Curb Ramps)

Intersection ID: 10018981 Main Street: DEVONGATE LN Cross Street: N/A Location: SE

Initial Pass/Fail: Pass **Overall Compliance: No Severity Score:** 7.5 ADA ID: C132FFBDB957 Ramp Type: BlendTrans1

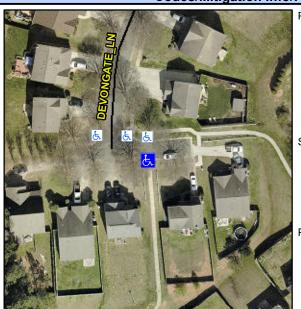
Total Cost: 700.00 Compliance Description Data Compliance Description Data Yes N/A Ramp Length (in) 60.5 BlendTrans Slope (%) 48.0 Yes Yes Ramp Width (in) BlendTrans XSlope (%) N/A N/A Flare Type LT Sloped Flare Type RT Sloped N/A Flare Slope LT (%) 12.3 N/A Flare Slope RT (%) N/A Flare Traversable LT? Nο N/A Flare Traversable RT? Landing Length (in) 48.0 Yes **DWS Provided?** Yes Yes Landing Width (in) 48.0 Yes **DWS Contrast?** 4.9 Yes No Landing Slope (%) DWS Length (in) 24.0 No Landing X Slope (%) 4.7 Yes DWS Full Width? N/A Landing Curb? (Y/N) No Yes DWS Offset (in) N/A Shared Landing? No **Gutter Ponding?** Yes Yes Gutter Slope (%) No No Gutter Lip Ht (in) 0.5 Yes Gutter X Slope (%) N/A Painted X Walk1? No N/A Painted X Walk2? X Walk 1 Direction To N X Walk 2 Direction N/A X Walk 2 Width (in) X Walk 1 Width (in) X Walk 1 Slope (%) 4.7 X Walk 2 Slope (%) X Walk 2 X Slope (%) X Walk 1 X Slope (%) 1.7 N/A N/A Ramp inside XWalk2? N/A Ramp inside XWalk1? Road Slope (%) 1.7 Clear Space? N/A Road X Slope (%) 4.7 Clear Space to XWalk (in) Any Obstructions? No Yes Yes Storm Grate/Utility Hazard? **Obstruction Type** Storm Grate/Utility Type N/A Yes Surface Condition? (G/P) Good

Street 1 Name **DEVONGATE LN** Stop Condition-Street 1 None N/A Street 2 Name Stop Condition-Street 2 N/A Possible Solutions: Remove & Replace Landing, Grind Gutter Lip. Surveyor Notes: N/A PROW/ADA: R304.2.2-Perp, R304.3.2-Para, R304.5.3, R302.7, R302.7.2
