Access Compliance Report

Public Rights-of-Way

(Curb Ramps)

Intersection ID: 29238	Main Street: POINTER RIDGE DR	Cross Street: WOODINGTON LN	Location: S
ADA ID: C139563FD6F0	Ramp Type: PerpDiag	Initial Pass/Fail: Fail	Overall Compliance: No
Codes/Mitigation Info/Possible Solution		Field Measurements/Component Compliance

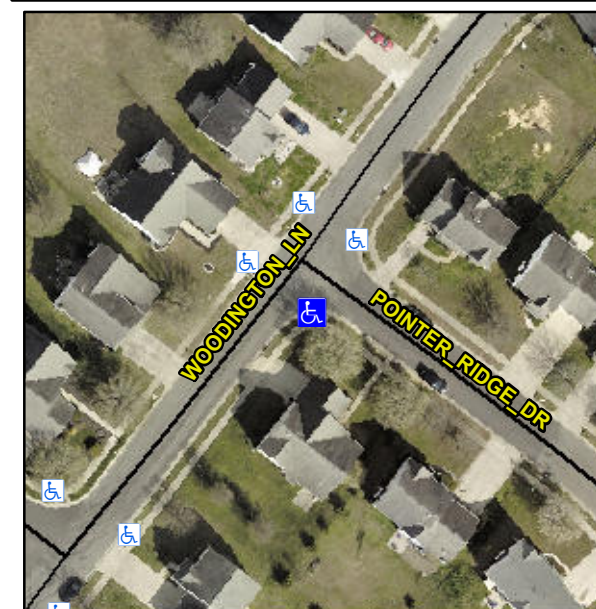
Not Found, R304.5.1, R304.5.3

Compliance	Description	Data	Compliance	Description	Data
N/A	Ramp Length (in)	49.0	Yes	Ramp Slope (%)	7.3
No	Ramp Width (in)	41.0	No	Ramp XSlope (%)	3.7
N/A	Flare Type LT	N/A	N/A	Flare Type RT	N/A
N/A	Flare Slope LT (%)	N/A	N/A	Flare Slope RT (%)	N/A
N/A	Flare Traversable LT?	N/A	N/A	Flare Traversable RT?	N/A
N/A	Landing Length (in)	N/A	N/A	DWS Provided?	N/A
N/A	Landing Width (in)	N/A	N/A	DWS Contrast?	N/A
N/A	Landing Slope (%)	N/A	N/A	DWS Length (in)	N/A
N/A	Landing X Slope (%)	N/A	N/A	DWS Full Width?	N/A
N/A	Landing Curb? (Y/N)	N/A	N/A	DWS Offset (in)	N/A
N/A	Shared Landing?	N/A			
N/A	Gutter Ponding?	N/A	N/A	Gutter Slope (%)	N/A
N/A	Gutter Lip Ht (in)	N/A	N/A	Gutter X Slope (%)	N/A
N/A	Painted X Walk1?	No	N/A	Painted X Walk2?	No
	X Walk 1 Direction	To NE		X Walk 2 Direction	To NW
N/A	X Walk 1 Width (in)	N/A	N/A	X Walk 2 Width (in)	N/A
	X Walk 1 Slope (%)	7.7		X Walk 2 Slope (%)	5.5
	X Walk 1 X Slope (%)	2.9		X Walk 2 X Slope (%)	6.9

N/A	Ramp inside XWalk1?	N/A	N/A	Ramp inside XWalk2?	N/A
	Road Slope (%)	2.6	N/A	Clear Space?	N/A
	Road X Slope (%)	6.6	N/A	Clear Space to XWalk (in)	N/A
N/A	Any Obstructions?	N/A	N/A	Storm Grate/Utility Hazard?	N/A
	Obstruction Type			Storm Grate/Utility Type	
		N/A			N/A
			Yes	Surface Condition? (G/P)	Good

Remove & Replace Curb Ramp With Two New Directional Ramps or Equivalent.
