Access Compliance Report

Public Rights-of-Way

(Curb Ramps)

Intersection ID: 20109	Main Street: COLUMBINE_CR	Cross Street: COLUMBINE_CT	Location: NW
ADA ID: C13E90DD0A08	Ramp Type: PerpDiag	Initial Pass/Fail: Fail	Overall Compliance: No
Severity Score: 13.75			
Codes/Mitigation Info/Possible Solution		Field Measurements/Component Compliance

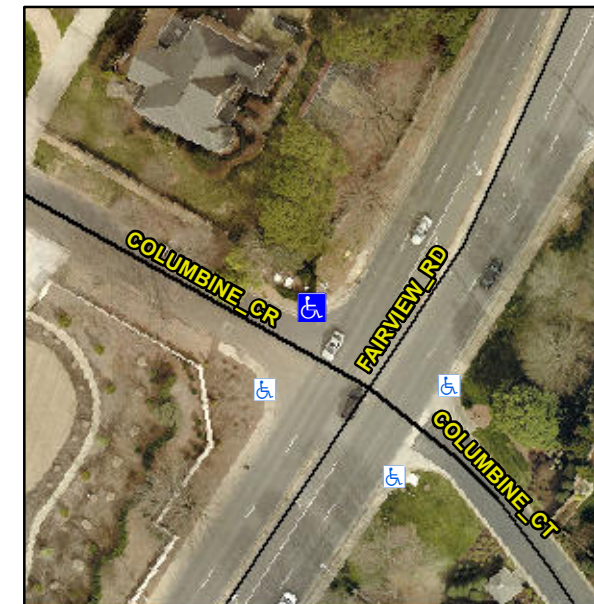
Compliance	Description	Data	Compliance	Description	Data
N/A	Ramp Length (in)	57.0	No	Ramp Slope (%)	8.7
Yes	Ramp Width (in)	48.0	No	Ramp XSlope (%)	3.0
N/A	Flare Type LT	N/A	N/A	Flare Type RT	N/A
N/A	Flare Slope LT (%)	N/A	N/A	Flare Slope RT (%)	N/A
N/A	Flare Traversable LT?	N/A	N/A	Flare Traversable RT?	N/A
N/A	Landing Length (in)	N/A	N/A	DWS Provided?	N/A
N/A	Landing Width (in)	N/A	N/A	DWS Contrast?	N/A
N/A	Landing Slope (%)	N/A	N/A	DWS Length (in)	N/A
N/A	Landing X Slope (%)	N/A	N/A	DWS Full Width?	N/A
N/A	Landing Curb? (Y/N)	N/A	N/A	DWS Offset (in)	N/A
N/A	Shared Landing?	N/A			
N/A	Gutter Ponding?	N/A	N/A	Gutter Slope (%)	N/A
N/A	Gutter Lip Ht (in)	N/A	N/A	Gutter X Slope (%)	N/A
N/A	Painted X Walk1?	No	N/A	Painted X Walk2?	No
	X Walk 1 Direction	To SW		X Walk 2 Direction	To SE
N/A	X Walk 1 Width (in)	N/A	N/A	X Walk 2 Width (in)	N/A
	X Walk 1 Slope (%)	0.6		X Walk 2 Slope (%)	4.2
	X Walk 1 X Slope (%)	4.8		X Walk 2 X Slope (%)	2.4

N/A	Ramp inside XWalk1?	N/A	N/A	Ramp inside XWalk2?	N/A
	Road Slope (%)	0.7	N/A	Clear Space?	N/A
	Road X Slope (%)	4.2	N/A	Clear Space to XWalk (in)	N/A
N/A	Any Obstructions?	N/A	N/A	Storm Grate/Utility Hazard?	N/A
	Obstruction Type			Storm Grate/Utility Type	
		N/A			N/A
		Yes		Surface Condition? (G/P)	Good

Possible Solutions:

Remove & Replace Curb Ramp With Two New Directional Ramps or Equivalent.

Not Found, R304.2.2, R304.5.3
