Access Compliance Report

Public Rights-of-Way

(Curb Ramps)

| Intersection ID: 9962 | Main Street: LITTLE ROCK RD | Cross Street: TUCKASEEGEE_RD | Location: E |

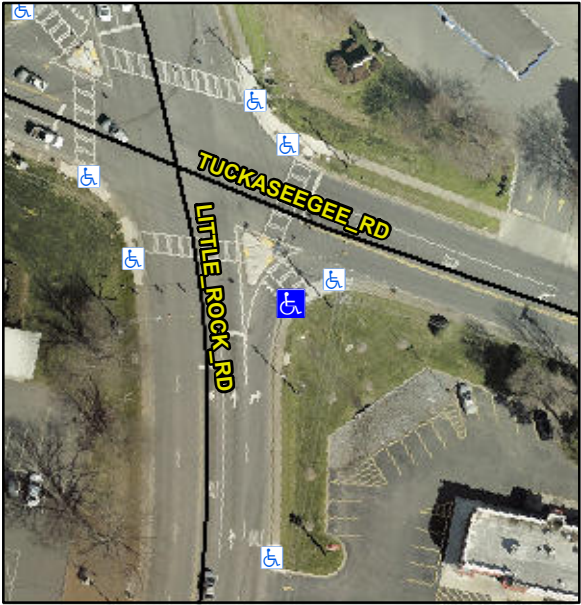
| ADA ID: C14CA34619F7 | Ramp Type: Perp | Initial Pass/Fail: Fail | Overall Compliance: No |

| Codes/Mitigation Info/Possible Solution | | | Field Measurements/Component Compliance | | |
|---|--|---|---|---|---|
| | Remove & Replace Entire Ramp. | | No | Ramp Length (in) | 48.5 |
| | | | No | Ramp Width (in) | 47.0 |
| <p>Surveyor Notes:</p> <p>N/A</p> <p>PROW/ADA:</p> <p>Not Found, R304.5.1, R304.2.2</p> | | | N/A | Flare Type RT | N/A |

| Codes/Mitigation Info/Possible Solution | | | Field Measurements/Component Compliance | | |
|---|--|---|---|---|---|
| | Possible Solutions: | | Compliance | Description | Data |

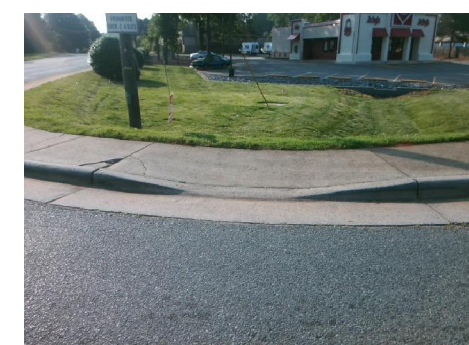
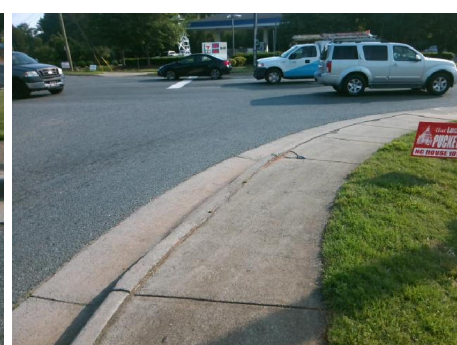
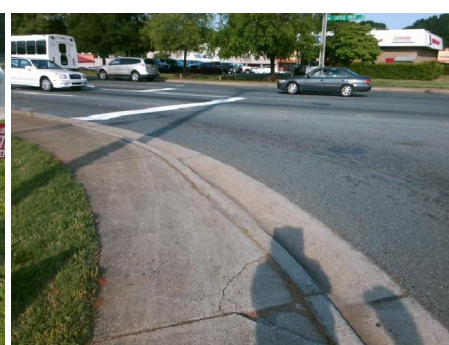
| Codes/Mitigation Info/Possible Solution | | | Field Measurements/Component Compliance | | |
|---|--|---|---|---|---|
| | | | Yes | Surface Condition? (G/P) | Good |
