## **Access Compliance Report Public Rights-of-Way** (Curb Ramps)

Intersection ID: 48463 Main Street: PANGLEMONT DR **Cross Street: CHANDLER HAVEN DR** Location: ADA ID: C1576C451717 Ramp Type: PerpDiag Initial Pass/Fail: Fail **Overall Compliance: No** Severity Score: 33.75

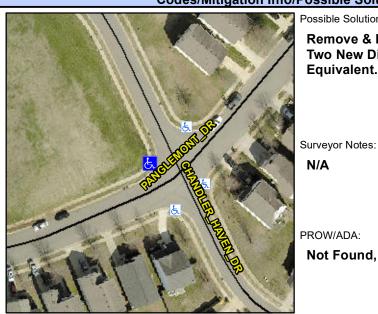
Not Found, R304.5.1, R304.2.2

Compliance Description		Data	Compliance		Description	Data
N/A	Ramp Length (in)	48.0	No	Ramp	Slope (%)	12.1
No	Ramp Width (in)	46.0	Yes	Ramp	XSlope (%)	0.5
N/A	Flare Type LT	N/A	N/A	Flare	Type RT	N/A
N/A	Flare Slope LT (%)	N/A	N/A	Flare	Slope RT (%)	N/A
N/A	Flare Traversable LT?	N/A	N/A	Flare	Traversable RT?	N/A
N/A	Landing Length (in)	N/A	N/A	DWS	Provided?	N/A
N/A	Landing Width (in)	N/A	N/A	DWS	Contrast?	N/A
N/A	Landing Slope (%)	N/A	N/A	DWS	Length (in)	N/A
N/A	Landing X Slope (%)	N/A	N/A	DWS	Full Width?	N/A
N/A	Landing Curb? (Y/N)	N/A	N/A	DWS	Offset (in)	N/A
N/A	Shared Landing?	N/A				
N/A	Gutter Ponding?	N/A	N/A	Gutte	r Slope (%)	N/A
N/A	Gutter Lip Ht (in)	N/A	N/A	Gutte	r X Slope (%)	N/A
N/A	Painted X Walk1?	No	N/A	Paint	ed X Walk2?	No
	X Walk 1 Direction	To S		X Wa	lk 2 Direction	To NE
N/A	X Walk 1 Width (in)	N/A	N/A	X Wa	lk 2 Width (in)	N/A
	X Walk 1 Slope (%)	0.1		X Wa	lk 2 Slope (%)	0.2
	X Walk 1 X Slope (%)	0.3		X Wa	lk 2 X Slope (%)	0.6

N/A	Ramp inside XWalk1?	N/A	N/A	Ramp	inside XWalk2?	N/A
	Road Slope (%)	0.1	N/A	Clear	Space?	N/A
	Road X Slope (%)	0.4	N/A	Clear	Space to XWalk (in)	N/A
N/A	Any Obstructions?	N/A	N/A	Storm	n Grate/Utility Hazard?	N/A
	Obstruction Type			Storm	n Grate/Utility Type	
		N/A				N/A

Possible Solutions: Remove & Replace Curb Ramp With Two New Directional Ramps or Equivalent.
