# Access Compliance Report

## Public Rights-of-Way

Intersection ID: 18244	Main Street: CROSBY_RD	Cross Street: S_SHARON_AMITY_RD	Location: SE
ADA ID: C15BA1D976AA	Ramp Type: PerpDiag	Initial Pass/Fail: Fail	Overall Compliance: No
Severity Score: 18.75			
Codes/Mitigation Info/Possible Solution		Field Measurements/Component Compliance

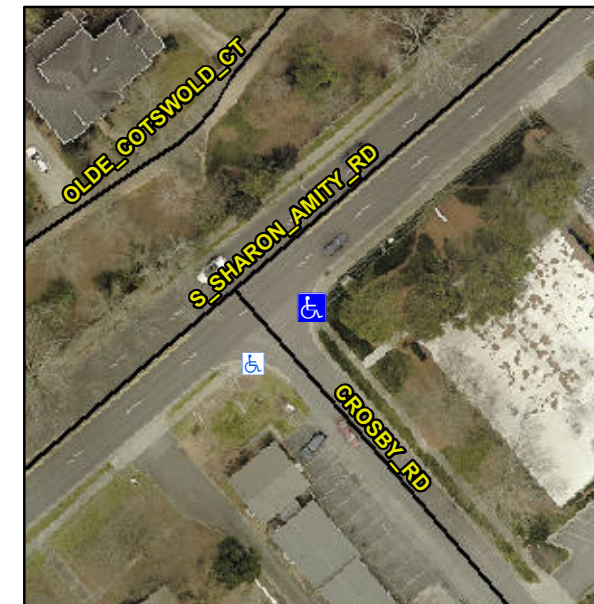
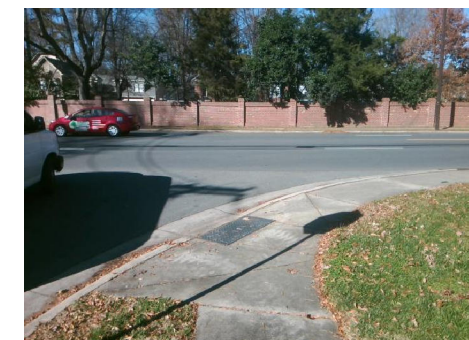
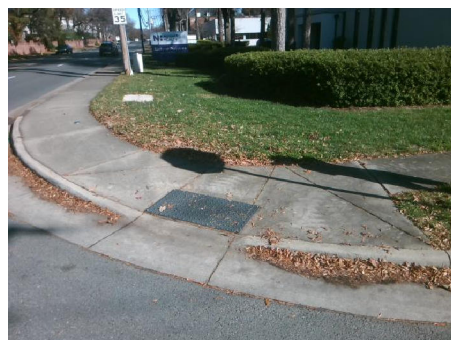
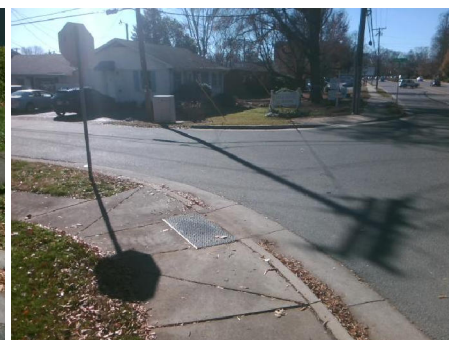
Compliance	Description	Data	Compliance	Description	Data
N/A	Ramp Length (in)	64.0	Yes	Ramp Slope (%)	6.6
No	Ramp Width (in)	34.0	No	Ramp XSlope (%)	3.1
N/A	Flare Type LT	N/A	N/A	Flare Type RT	N/A
N/A	Flare Slope LT (%)	N/A	N/A	Flare Slope RT (%)	N/A
N/A	Flare Traversable LT?	N/A	N/A	Flare Traversable RT?	N/A
N/A	Landing Length (in)	N/A	N/A	DWS Provided?	N/A
N/A	Landing Width (in)	N/A	N/A	DWS Contrast?	N/A
N/A	Landing Slope (%)	N/A	N/A	DWS Length (in)	N/A
N/A	Landing X Slope (%)	N/A	N/A	DWS Full Width?	N/A
N/A	Landing Curb? (Y/N)	N/A	N/A	DWS Offset (in)	N/A
N/A	Shared Landing?	N/A			
N/A	Gutter Ponding?	N/A	N/A	Gutter Slope (%)	N/A
N/A	Gutter Lip Ht (in)	N/A	N/A	Gutter X Slope (%)	N/A
N/A	Painted X Walk1?	No	N/A	Painted X Walk2?	No
	X Walk 1 Direction	To NW		X Walk 2 Direction	To SW
N/A	X Walk 1 Width (in)	N/A	N/A	X Walk 2 Width (in)	N/A
	X Walk 1 Slope (%)	4.4		X Walk 2 Slope (%)	3.7
	X Walk 1 X Slope (%)	1.2		X Walk 2 X Slope (%)	3.9

N/A	Ramp inside XWalk1?	N/A	N/A	Ramp inside XWalk2?	N/A
	Road Slope (%)	0.8	N/A	Clear Space?	N/A
	Road X Slope (%)	3.3	N/A	Clear Space to XWalk (in)	N/A
N/A	Any Obstructions?	N/A	N/A	Storm Grate/Utility Hazard?	N/A
	Obstruction Type			Storm Grate/Utility Type	
		N/A			N/A
			Yes	Surface Condition? (G/P)	Good

**Remove & Replace Curb Ramp With Two New Directional Ramps or Equivalent.**

**R304.5.1, R304.5.3**
