# Access Compliance Report

## Public Rights-of-Way

### (Curb Ramps)

| Intersection ID: N/A | Main Street: BALLANTYNE_VILLAGE_DR | Cross Street: N/A | Location: NE |

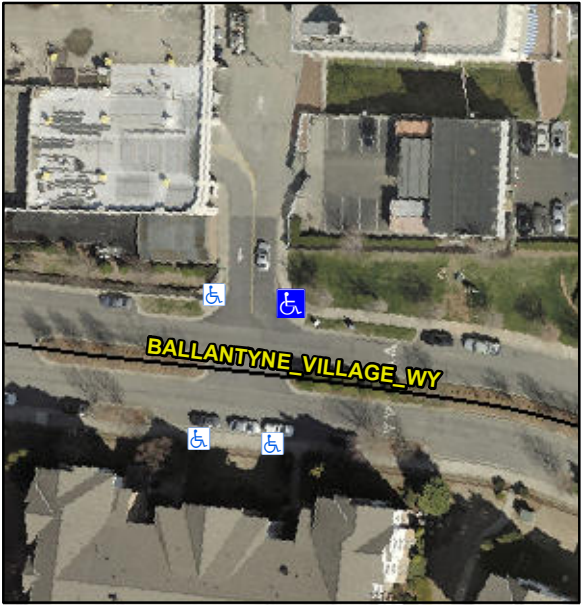
| ADA ID: C15CF12B3647 | Ramp Type: PerpDiag | Initial Pass/Fail: Fail | Overall Compliance: No |

| Severity Score: 31.25 | | | |

| | Remove & Replace Curb Ramp With Two New Directional Ramps or Equivalent. | | N/A | Ramp Length (in) | 61.0 | No | Ramp Slope (%) | 8.5 |
| <p>Surveyor Notes:</p> <p>N/A</p> <p>PROW/ADA:</p> <p>Not Found, R304.5.1, R304.2.2, R304.5.3</p> | | | No | Ramp Width (in) | 33.0 | No | Ramp XSlope (%) | 3.9 |

| | Possible Solutions: | | Compliance | Description | Data | Compliance | Description | Data |
