Access Compliance Report

Public Rights-of-Way

(Curb Ramps)

Intersection ID: 21081	Main Street: BECKFORD_DR	Cross Street: SHARON_VIEW_RD	Location: NW
ADA ID: C16E98E3617E	Ramp Type: BlendTrans2	Initial Pass/Fail: Fail	Overall Compliance: No
			Severity Score: 36.25

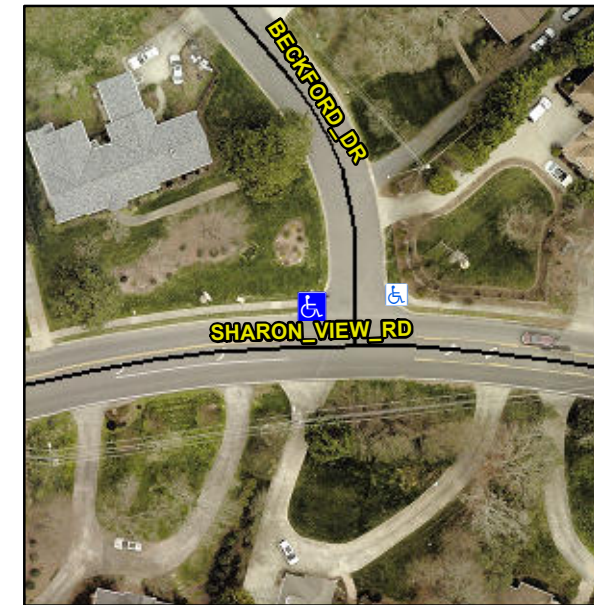
Compliance	Description	Data	Compliance	Description	Data
N/A	Ramp Length (in)	76.5	Yes	BlendTrans Slope (%)	4.1
No	Ramp Width (in)	27.0	No	BlendTrans XSlope (%)	2.6
N/A	Flare Type LT	N/A	N/A	Flare Type RT	N/A
N/A	Flare Slope LT (%)	N/A	N/A	Flare Slope RT (%)	N/A
N/A	Flare Traversable LT?	N/A	N/A	Flare Traversable RT?	N/A
N/A	Landing Length (in)	N/A	N/A	DWS Provided?	N/A
N/A	Landing Width (in)	N/A	N/A	DWS Contrast?	N/A
N/A	Landing Slope (%)	N/A	N/A	DWS Length (in)	N/A
N/A	Landing X Slope (%)	N/A	N/A	DWS Full Width?	N/A
N/A	Landing Curb? (Y/N)	N/A	N/A	DWS Offset (in)	N/A
N/A	Shared Landing?	N/A			
N/A	Gutter Ponding?	N/A	N/A	Gutter Slope (%)	N/A
N/A	Gutter Lip Ht (in)	N/A	N/A	Gutter X Slope (%)	N/A
N/A	Painted X Walk1?	No	N/A	Painted X Walk2?	No
	X Walk 1 Direction	To S		X Walk 2 Direction	To E
	X Walk 1 Width (in)	N/A		X Walk 2 Width (in)	N/A
	X Walk 1 Slope (%)	7.5		X Walk 2 Slope (%)	1.2
	X Walk 1 X Slope (%)	1.7		X Walk 2 X Slope (%)	3.7

N/A	Ramp inside XWalk1?	N/A	N/A	Ramp inside XWalk2?	N/A
	Road Slope (%)	2.8		Clear Space?	N/A
	Road X Slope (%)	7.0	N/A	Clear Space to XWalk (in)	N/A
N/A	Any Obstructions?	N/A	N/A	Storm Grate/Utility Hazard?	N/A
	Obstruction Type			Storm Grate/Utility Type	
		N/A			N/A
			Yes	Surface Condition? (G/P)	Good
			N/A	Curb Slope (%)	3.3

Remove & Replace Curb Ramp With Two New Directional Ramps or Equivalent.

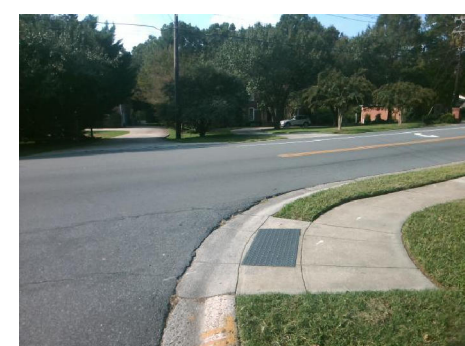
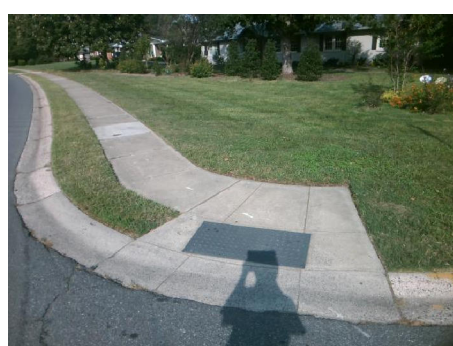
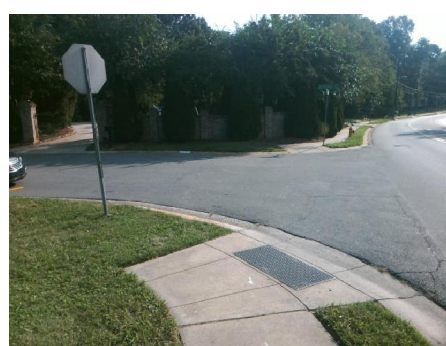
Street 1 Name **SHARON VIEW RD**
 Stop Condition-Street 1 **None**
 Street 2 Name **BECKFORD DR**
 Stop Condition-Street 2 **StopSign**
