Access Compliance Report

Public Rights-of-Way

(Curb Ramps)

Intersection ID: 11639	Main Street: PARKWOOD_AV	Cross Street: PEGRAM_ST	Location: SE
ADA ID: C17714A0D643	Ramp Type: PerpDiag	Initial Pass/Fail: Fail	Overall Compliance: No
Codes/Mitigation Info/Possible Solution		Field Measurements/Component Compliance	
Severity Score: 8.75

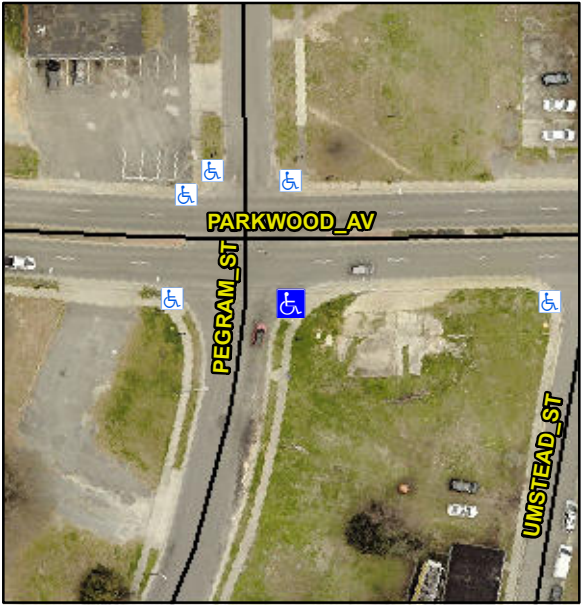
Possible Solutions:		Compliance		Description		Data	Compliance	Description	Data
	Remove & Replace Curb Ramp With Two New Directional Ramps or Equivalent.		N/A		Ramp Length (in)		118.0	Yes	Ramp Slope (%)	5.5
<p>Surveyor Notes:</p> <p>N/A</p> <p>PROW/ADA:</p> <p>Not Found, R304.5.1</p>			No		Ramp Width (in)		44.0	Yes	Ramp XSlope (%)	1.8
			N/A		Flare Type LT		N/A	N/A	Flare Type RT	N/A
			N/A		Flare Slope LT (%)		N/A	N/A	Flare Slope RT (%)	N/A
			N/A		Flare Traversable LT?		N/A	N/A	Flare Traversable RT?	N/A
			N/A		Landing Length (in)		N/A	N/A	DWS Provided?	N/A
			N/A		Landing Width (in)		N/A	N/A	DWS Contrast?	N/A
			N/A		Landing Slope (%)		N/A	N/A	DWS Length (in)	N/A
			N/A		Landing X Slope (%)		N/A	N/A	DWS Full Width?	N/A
			N/A		Landing Curb? (Y/N)		N/A	N/A	DWS Offset (in)	N/A
			N/A		Shared Landing?		N/A			
			N/A		Gutter Ponding?		N/A	N/A	Gutter Slope (%)	N/A
			N/A		Gutter Lip Ht (in)		N/A	N/A	Gutter X Slope (%)	N/A

N/A		Painted X Walk1?		No	N/A	Painted X Walk2?	No
					X Walk 1 Direction		To N		X Walk 2 Direction	To W
			N/A		X Walk 1 Width (in)		N/A	N/A	X Walk 2 Width (in)	N/A
					X Walk 1 Slope (%)		4.1		X Walk 2 Slope (%)	1.5
					X Walk 1 X Slope (%)		1.1		X Walk 2 X Slope (%)	3.6
			N/A		Ramp inside XWalk1?		N/A	N/A	Ramp inside XWalk2?	N/A
					Road Slope (%)		0.4	N/A	Clear Space?	N/A
					Road X Slope (%)		5.0	N/A	Clear Space to XWalk (in)	N/A
			N/A		Any Obstructions?		N/A	N/A	Storm Grate/Utility Hazard?	N/A
					Obstruction Type				Storm Grate/Utility Type	
								N/A		N/A
								Yes	Surface Condition? (G/P)	Good
