Access Compliance Report Public Rights-of-Way (Curb Ramps)

Intersection ID: 52915	Main Street: WILLOW_GREEN_PL	Cross Street: WOODWARD_AV	Location: NE
ADA ID: C18D2E211A8D	Ramp Type: Directional1	Initial Pass/Fail: Fail	Overall Compliance: No Severity Score: 12.5

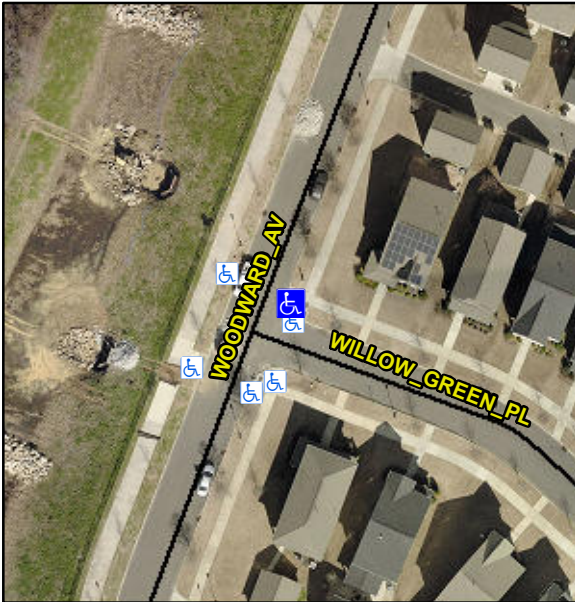
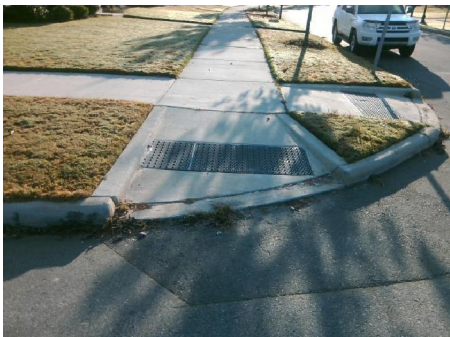
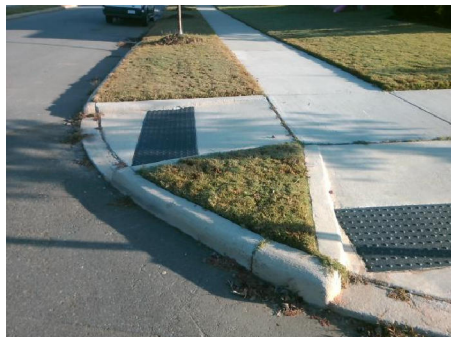
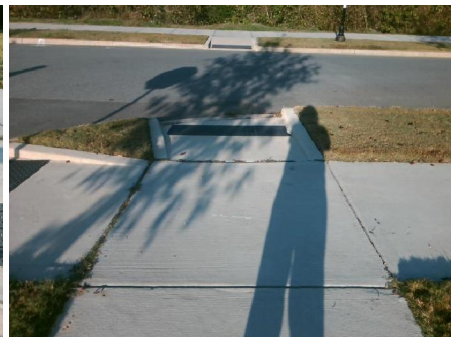
Compliance	Description	Data	Compliance	Description	Data
N/A	Ramp Length (in)	66.0	N/A	Grade Break?	N/A
Yes	Ramp Width (in)	59.0	N/A	Grade Break Slope (%)	0.0
No	Ramp Slope (%)	10.4	N/A	Grade Break XSlope (%)	0.0
Yes	Ramp XSlope (%)	1.1			
N/A	Flare Type LT	N/A	N/A	Flare Type RT	N/A
N/A	Flare Slope LT (%)	N/A	N/A	Flare Slope RT (%)	0.0
N/A	Flare Traversable LT?	N/A	N/A	Flare Traversable RT?	N/A
N/A	Landing Length (in)	0.0	N/A	DWS Provided?	N/A
N/A	Landing Width (in)	0.0	N/A	DWS Contrast?	N/A
N/A	Landing Slope (%)	0.0	N/A	DWS Length (in)	N/A
N/A	Landing X Slope (%)	0.0	N/A	DWS Full Width?	N/A
N/A	Landing Curb? (Y/N)	N/A	N/A	DWS Offset LT (in)	N/A
N/A	Shared Landing?	N/A	N/A	DWS Offset RT (in)	N/A
N/A	Gutter Ponding?	0.0	N/A	Gutter Slope (%)	N/A
N/A	Gutter Lip Ht (in)	0.0	N/A	Gutter X Slope (%)	N/A
N/A	Painted X Walk1?	No		Road Slope (%)	4.0
	X Walk 1 Direction	To W		Road X Slope (%)	1.3
	X Walk 1 Width (in)	N/A		Clear Space?	N/A

X Walk 1 Slope (%)	4.0	N/A	Clear Space to XWalk (in)	N/A
	X Walk 1 X Slope (%)	1.3	N/A	Storm Grate/Utility Hazard?	N/A
N/A	Ramp inside XWalk1?	N/A		Storm Grate/Utility Type	
N/A	Any Obstructions?	N/A			N/A
	Obstruction Type		Yes	Surface Condition? (G/P)	Good
			N/A	Curb Slope (%)	2.6

Possible Solutions:

Remove & Replace Entire Ramp.

R304.2.2

Total Cost: \$ **1600.00**
