Access Compliance Report

Public Rights-of-Way

(Curb Ramps)

Intersection ID: 31907	Main Street: PALOMAR_MOUNTAIN_DR	Cross Street: SPRUCE_PEAK_RD	Location: NW
ADA ID: C19186D87712	Ramp Type: PerpDiag	Initial Pass/Fail: Fail	Overall Compliance: No
Severity Score: 8.75			
Codes/Mitigation Info/Possible Solution		Field Measurements/Component Compliance

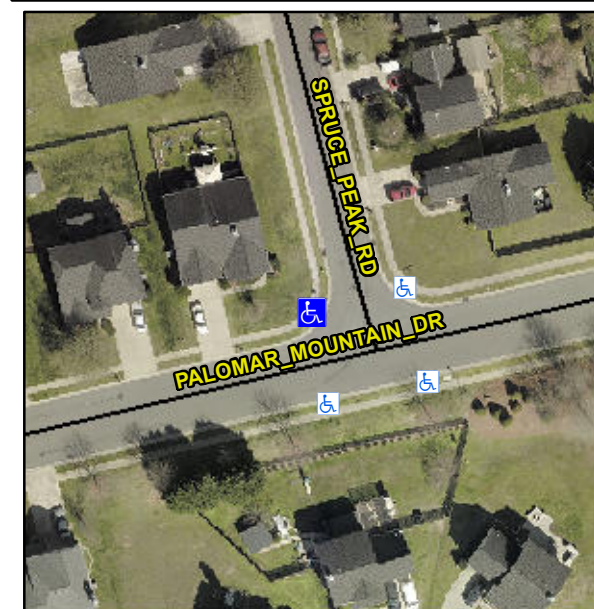
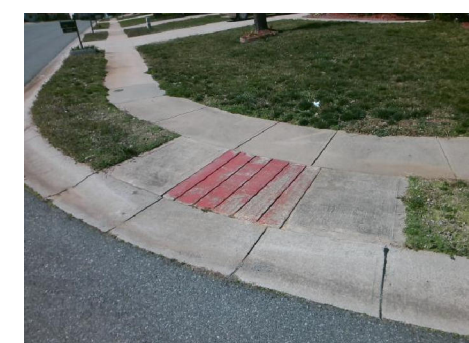
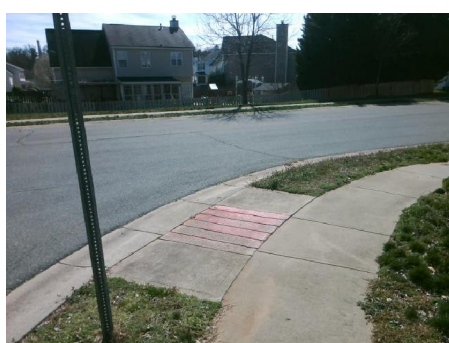
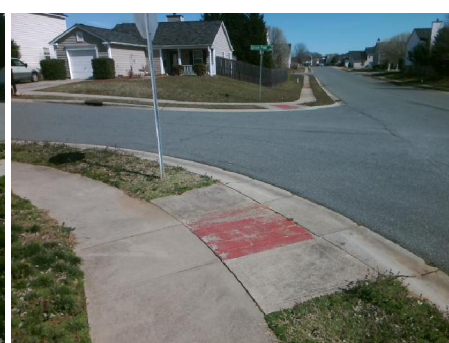
Compliance	Description	Data	Compliance	Description	Data
N/A	Ramp Length (in)	48.0	Yes	Ramp Slope (%)	5.6
No	Ramp Width (in)	44.5	Yes	Ramp XSlope (%)	1.2
N/A	Flare Type LT	N/A	N/A	Flare Type RT	N/A
N/A	Flare Slope LT (%)	N/A	N/A	Flare Slope RT (%)	N/A
N/A	Flare Traversable LT?	N/A	N/A	Flare Traversable RT?	N/A
N/A	Landing Length (in)	N/A	N/A	DWS Provided?	N/A
N/A	Landing Width (in)	N/A	N/A	DWS Contrast?	N/A
N/A	Landing Slope (%)	N/A	N/A	DWS Length (in)	N/A
N/A	Landing X Slope (%)	N/A	N/A	DWS Full Width?	N/A
N/A	Landing Curb? (Y/N)	N/A	N/A	DWS Offset (in)	N/A
N/A	Shared Landing?	N/A			
N/A	Gutter Ponding?	N/A	N/A	Gutter Slope (%)	N/A
N/A	Gutter Lip Ht (in)	N/A	N/A	Gutter X Slope (%)	N/A
N/A	Painted X Walk1?	No	N/A	Painted X Walk2?	No
	X Walk 1 Direction	To S		X Walk 2 Direction	To E
N/A	X Walk 1 Width (in)	N/A	N/A	X Walk 2 Width (in)	N/A
	X Walk 1 Slope (%)	0.4		X Walk 2 Slope (%)	2.0
	X Walk 1 X Slope (%)	1.9		X Walk 2 X Slope (%)	5.3

N/A	Ramp inside XWalk1?	N/A	N/A	Ramp inside XWalk2?	N/A
	Road Slope (%)	1.4	N/A	Clear Space?	N/A
	Road X Slope (%)	7.3	N/A	Clear Space to XWalk (in)	N/A
N/A	Any Obstructions?	N/A	N/A	Storm Grate/Utility Hazard?	N/A
	Obstruction Type			Storm Grate/Utility Type	
		N/A			N/A
			Yes	Surface Condition? (G/P)	Good

Possible Solutions:

Remove & Replace Curb Ramp With Two New Directional Ramps or Equivalent.

R304.5.1

Total Cost: \$ 3200.00
