Access Compliance Report

Public Rights-of-Way

(Curb Ramps)

Intersection ID: 12370	Main Street: CLARKSON_ST	Cross Street: POST_ST	Location:	E
ADA ID: C197EEC96145	Ramp Type: BlendTrans1	Initial Pass/Fail: Fail	Overall Compliance: No	Severity Score: 12.5
Codes/Mitigation Info/Possible Solution		Field Measurements/Component Compliance

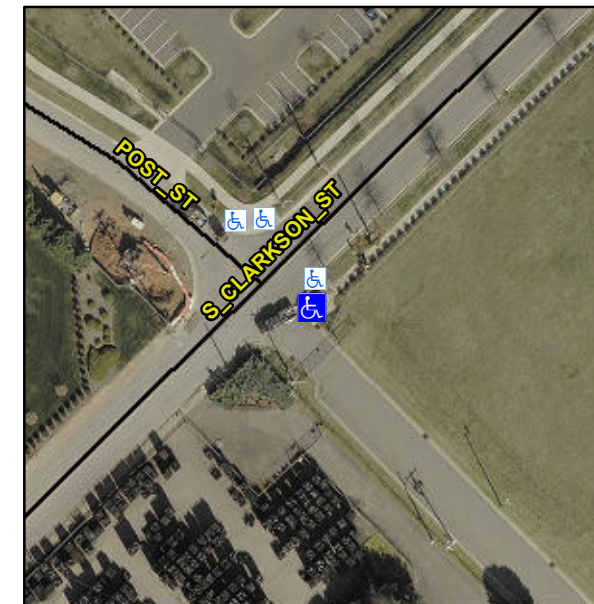
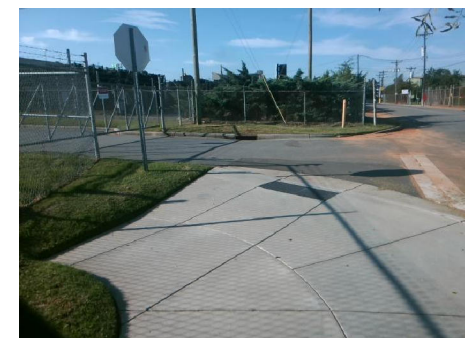
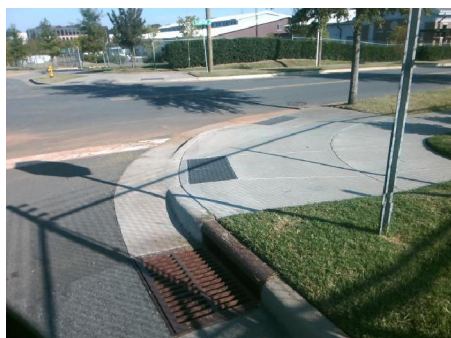
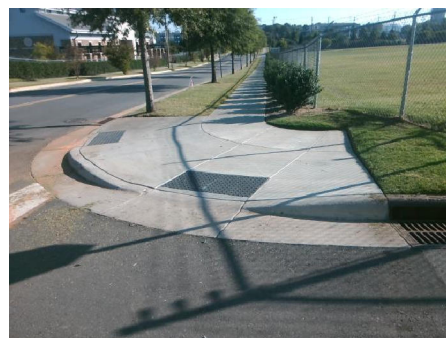
Compliance	Description	Data	Compliance	Description	Data
N/A	Ramp Length (in)	28.0	Yes	BlendTrans Slope (%)	3.5
Yes	Ramp Width (in)	48.0	No	BlendTrans XSlope (%)	6.3
N/A	Flare Type LT	N/A	N/A	Flare Type RT	N/A
N/A	Flare Slope LT (%)	N/A	N/A	Flare Slope RT (%)	N/A
N/A	Flare Traversable LT?	N/A	N/A	Flare Traversable RT?	N/A
N/A	Landing Length (in)	N/A	N/A	DWS Provided?	N/A
N/A	Landing Width (in)	N/A	N/A	DWS Contrast?	N/A
N/A	Landing Slope (%)	N/A	N/A	DWS Length (in)	N/A
N/A	Landing X Slope (%)	N/A	N/A	DWS Full Width?	N/A
N/A	Landing Curb? (Y/N)	N/A	N/A	DWS Offset (in)	N/A
N/A	Shared Landing?	N/A			
N/A	Gutter Ponding?	N/A	N/A	Gutter Slope (%)	N/A
N/A	Gutter Lip Ht (in)	N/A	N/A	Gutter X Slope (%)	N/A
N/A	Painted X Walk1?	No	N/A	Painted X Walk2?	N/A
	X Walk 1 Direction	To SW		X Walk 2 Direction	N/A
	X Walk 1 Width (in)	N/A		X Walk 2 Width (in)	N/A
	X Walk 1 Slope (%)	1.6		X Walk 2 Slope (%)	N/A
	X Walk 1 X Slope (%)	5.2		X Walk 2 X Slope (%)	N/A

N/A	Ramp inside XWalk1?	N/A	N/A	Ramp inside XWalk2?	N/A
	Road Slope (%)	5.2		Clear Space?	N/A
	Road X Slope (%)	1.6	N/A	Clear Space to XWalk (in)	N/A
N/A	Any Obstructions?	N/A	N/A	Storm Grate/Utility Hazard?	N/A
	Obstruction Type			Storm Grate/Utility Type	
		N/A			N/A
			Yes	Surface Condition? (G/P)	Good
			N/A	Curb Slope (%)	0.3

Remove & Replace Curb Ramp With Two New Directional Ramps or Equivalent.

R304.5.3
