Access Compliance Report Public Rights-of-Way (Curb Ramps)

Intersection ID: 18012 Main Street: RAMA_RD Cross Street: CHARING PL Location: NW ADA ID: C19A4F39C3E9 Ramp Type: PerpDiag Initial Pass/Fail: Fail **Overall Compliance: No Severity Score:** 12.5

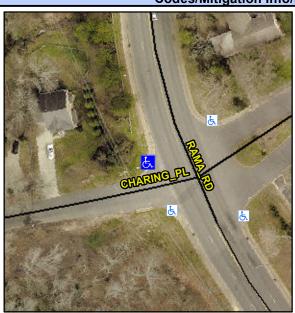
CHARING PL Street 1 Name Stop Condition-Street 2 Street 2 Name **RAMA RD** Stop Condition-Street 1

Not Found, R304.5.3

Field Measurements/Component Compnance					
Compliance Description		Data	Compliance Description		Data
N/A	Ramp Length (in)	61.0	Yes	Ramp Slope (%)	7.6
Yes	Ramp Width (in)	48.0	No	Ramp XSlope (%)	5.6
N/A	Flare Type LT	N/A	N/A	Flare Type RT	N/A
N/A	Flare Slope LT (%)	N/A	N/A	Flare Slope RT (%)	N/A
N/A	Flare Traversable LT?	N/A	N/A	Flare Traversable RT?	N/A
N/A	Landing Length (in)	N/A	N/A	DWS Provided?	N/A
N/A	Landing Width (in)	N/A	N/A	DWS Contrast?	N/A
N/A	Landing Slope (%)	N/A	N/A	DWS Length (in)	N/A
N/A	Landing X Slope (%)	N/A	N/A	DWS Full Width?	N/A
N/A	Landing Curb? (Y/N)	N/A	N/A	DWS Offset (in)	N/A
N/A	Shared Landing?	N/A			
N/A	Gutter Ponding?	N/A	N/A	Gutter Slope (%)	N/A
N/A	Gutter Lip Ht (in)	N/A	N/A	Gutter X Slope (%)	N/A
N/A	Painted X Walk1?	No	N/A	Painted X Walk2?	No
	X Walk 1 Direction	To SE		X Walk 2 Direction	To NE
N/A	X Walk 1 Width (in)	N/A	N/A	X Walk 2 Width (in)	N/A
	X Walk 1 Slope (%)	3.6		X Walk 2 Slope (%)	3.6

X Walk 1 X Slope (%)	1.4		X Walk 2 X Slope (%)	2.0
N/A	Ramp inside XWalk1?	N/A	N/A	Ramp inside XWalk2?	N/A
	Road Slope (%)	3.5	N/A	Clear Space?	N/A
	Road X Slope (%)	2.0	N/A	Clear Space to XWalk (in)	N/A
N/A	Any Obstructions?	N/A	N/A	Storm Grate/Utility Hazard?	N/A
	Obstruction Type			Storm Grate/Utility Type	
		N/A			N/A

Remove & Replace Curb Ramp With Two New Directional Ramps or Equivalent.
