Access Compliance Report

Public Rights-of-Way

(Curb Ramps)

Intersection ID: 28975	Main Street: BANNINGTON_RD	Cross Street: NORTHBURY_LN	Location: NW
ADA ID: C1A661BECEE6	Ramp Type: PerpDiag	Initial Pass/Fail: Fail	Overall Compliance: No
		Severity Score: 60

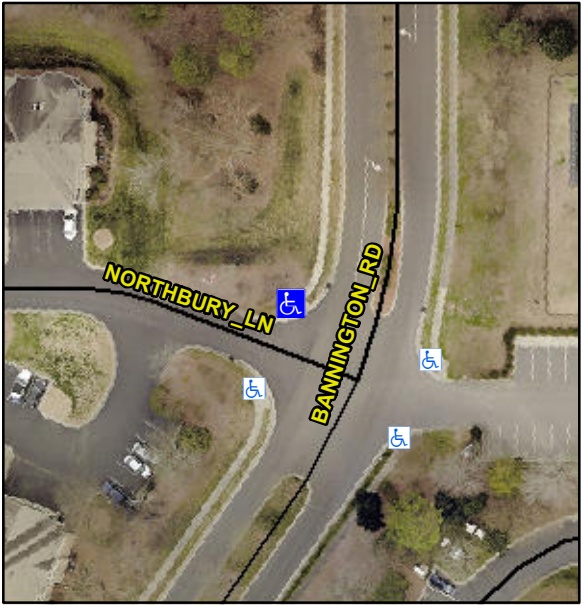
<p>Street 1 Name NORTHBURY LN</p> <p>Stop Condition-Street 2 StopSign</p> <p>Street 2 Name BANNINGTON RD</p> <p>Stop Condition-Street 1 None</p>	Possible Solutions:		Compliance	Description	Data
	Remove & Replace Curb Ramp With Two New Directional Ramps or Equivalent.		Yes	Ramp Slope (%)	6.0
			No	Ramp XSlope (%)	7.1
			N/A	Flare Type LT	N/A
			N/A	Flare Slope LT (%)	N/A
			N/A	Flare Traversable LT?	N/A
			N/A	Flare Traversable RT?	N/A
			N/A	DWS Provided?	N/A
			N/A	DWS Contrast?	N/A
			N/A	DWS Length (in)	N/A
			N/A	DWS Full Width?	N/A
			N/A	DWS Offset (in)	N/A
			N/A	Gutter Slope (%)	N/A
			N/A	Gutter X Slope (%)	N/A
			No	Painted X Walk2?	No
			To S	X Walk 2 Direction	To E
			N/A	X Walk 2 Width (in)	N/A

6.1	X Walk 2 Slope (%)	1.8
			2.0	X Walk 2 X Slope (%)	6.3
			N/A	Ramp inside XWalk2?	N/A
<p>Surveyor Notes:</p> <p>N/A</p> <p>PROW/ADA:</p> <p>Not Found, R304.5.1, R304.5.3</p> <p>Total Cost: \$ 3200.00</p>			N/A	Clear Space?	N/A

3.0	Clear Space to XWalk (in)	N/A
			4.7	Storm Grate/Utility Hazard?	N/A
			N/A	Storm Grate/Utility Type	N/A
			N/A	Obstruction Type	N/A
			N/A	Surface Condition? (G/P)	Good
