Access Compliance Report

Public Rights-of-Way

(Curb Ramps)

Intersection ID: N/A	Main Street: SPRING FROST CT	Cross Street: N/A	Location: NE
ADA ID: C1AEB15558D5	Ramp Type: Perp	Initial Pass/Fail: Fail	Overall Compliance: No
Severity Score: 33.75			
Codes/Mitigation Info/Possible Solution		Field Measurements/Component Compliance

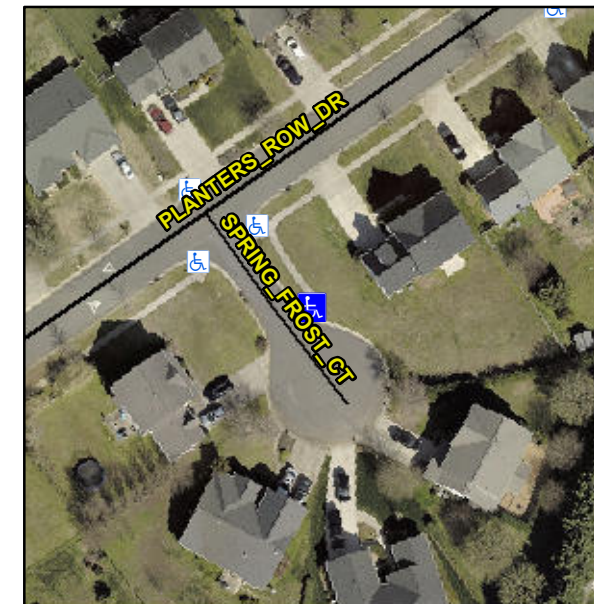
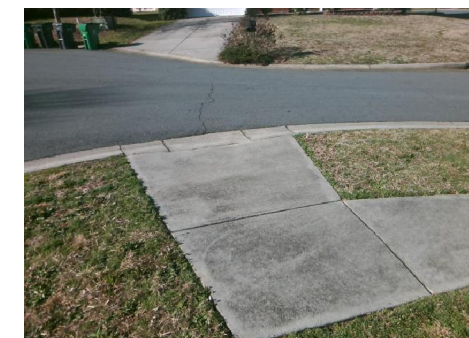
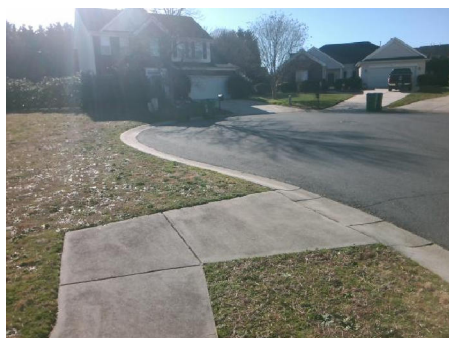
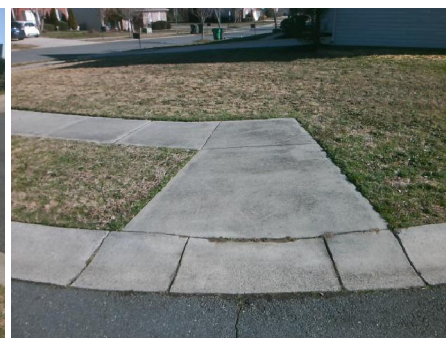
Compliance	Description	Data	Compliance	Description	Data
N/A	Ramp Length (in)	82.0	Yes	Ramp Slope (%)	5.7
No	Ramp Width (in)	46.0	No	Ramp XSlope (%)	7.3
N/A	Flare Type LT	N/A	N/A	Flare Type RT	N/A
N/A	Flare Slope LT (%)	N/A	N/A	Flare Slope RT (%)	N/A
N/A	Flare Traversable LT?	N/A	N/A	Flare Traversable RT?	N/A
N/A	Landing Length (in)	N/A	N/A	DWS Provided?	N/A
N/A	Landing Width (in)	N/A	N/A	DWS Contrast?	N/A
N/A	Landing Slope (%)	N/A	N/A	DWS Length (in)	N/A
N/A	Landing X Slope (%)	N/A	N/A	DWS Full Width?	N/A
N/A	Landing Curb? (Y/N)	N/A	N/A	DWS Offset (in)	N/A
N/A	Shared Landing?	N/A			
N/A	Gutter Ponding?	N/A	N/A	Gutter Slope (%)	N/A
N/A	Gutter Lip Ht (in)	N/A	N/A	Gutter X Slope (%)	N/A
N/A	Painted X Walk1?	No	N/A	Painted X Walk2?	N/A
	X Walk 1 Direction	To SW		X Walk 2 Direction	N/A
N/A	X Walk 1 Width (in)	N/A	N/A	X Walk 2 Width (in)	N/A
	X Walk 1 Slope (%)	3.3		X Walk 2 Slope (%)	N/A
	X Walk 1 X Slope (%)	4.8		X Walk 2 X Slope (%)	N/A

N/A	Ramp inside XWalk1?	N/A	N/A	Ramp inside XWalk2?	N/A
	Road Slope (%)	N/A	N/A	Clear Space?	N/A
	Road X Slope (%)	N/A	N/A	Clear Space to XWalk (in)	N/A
N/A	Any Obstructions?	N/A	N/A	Storm Grate/Utility Hazard?	N/A
	Obstruction Type			Storm Grate/Utility Type	
		N/A			N/A
			Yes	Surface Condition? (G/P)	Good

Possible Solutions:

Remove & Replace Entire Ramp.

PROW/ADA:

R304.5.1, R304.5.3
