Access Compliance Report

Public Rights-of-Way

(Curb Ramps)

Intersection ID: 15123	Main Street: EASTWAY_DR_RA	Cross Street: EASTWAY_DR	Location: SE
ADA ID: C1BB9AD0EAF9	Ramp Type: Perp	Initial Pass/Fail: Fail	Overall Compliance: No
Codes/Mitigation Info/Possible Solution		Field Measurements/Component Compliance	
Severity Score: 21.25

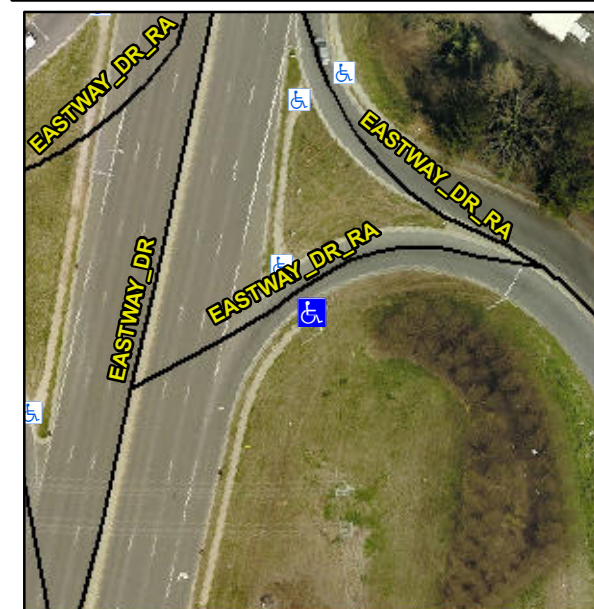
Not Found, R304.5.1, R304.5.3

Compliance	Description	Data	Compliance	Description	Data
N/A	Ramp Length (in)	89.0	Yes	Ramp Slope (%)	6.3
No	Ramp Width (in)	43.0	No	Ramp XSlope (%)	6.0
N/A	Flare Type LT	N/A	N/A	Flare Type RT	N/A
N/A	Flare Slope LT (%)	N/A	N/A	Flare Slope RT (%)	N/A
N/A	Flare Traversable LT?	N/A	N/A	Flare Traversable RT?	N/A
N/A	Landing Length (in)	N/A	N/A	DWS Provided?	N/A
N/A	Landing Width (in)	N/A	N/A	DWS Contrast?	N/A
N/A	Landing Slope (%)	N/A	N/A	DWS Length (in)	N/A
N/A	Landing X Slope (%)	N/A	N/A	DWS Full Width?	N/A
N/A	Landing Curb? (Y/N)	N/A	N/A	DWS Offset (in)	N/A
N/A	Shared Landing?	N/A			
N/A	Gutter Ponding?	N/A	N/A	Gutter Slope (%)	N/A
N/A	Gutter Lip Ht (in)	N/A	N/A	Gutter X Slope (%)	N/A
N/A	Painted X Walk1?	No	N/A	Painted X Walk2?	N/A
	X Walk 1 Direction	To NW		X Walk 2 Direction	N/A
N/A	X Walk 1 Width (in)	N/A	N/A	X Walk 2 Width (in)	N/A
	X Walk 1 Slope (%)	3.1		X Walk 2 Slope (%)	N/A
	X Walk 1 X Slope (%)	4.9		X Walk 2 X Slope (%)	N/A

Remove & Replace Entire Ramp.
