# Access Compliance Report

## Public Rights-of-Way

### (Curb Ramps)

| Intersection ID: 24484 | Main Street: SAINTFIELD_PL | Cross Street: SWINFORD_PL | Location: NW |

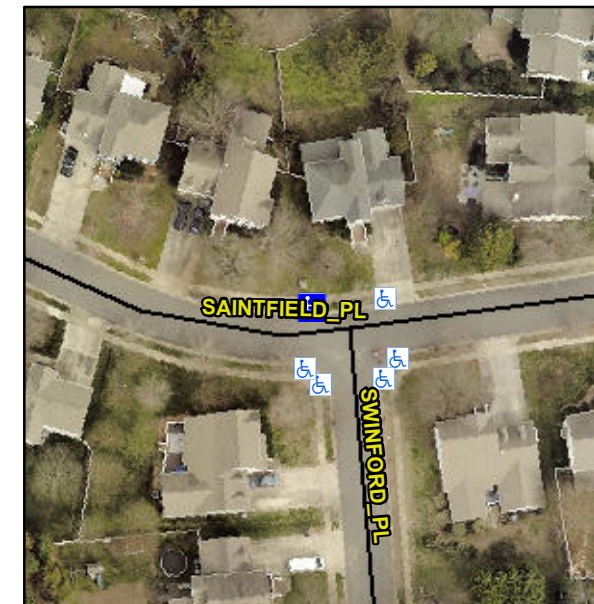
#### Field Measurements/Component Compliance

| Compliance | Description | Data | Compliance | Description | Data |
|---|---|---|---|---|---|
| No | Landing Length (in) | 45.0 | No | DWS Provided? | No |
| No | Landing Slope (%) | 5.2 | N/A | DWS Length (in) | N/A |
| No | Gutter Ponding? | Yes | No | Gutter Slope (%) | 10.6 |

Possible Solutions:

**Remove & Replace Entire Ramp.  
Remove & Replace Gutter.**
