Access Compliance Report

Public Rights-of-Way

(Curb Ramps)

Intersection ID: 48945	Main Street: DAVID_JENNINGS_AV	Cross Street: CALDWELL_RIDGE_PY	Location: SW
ADA ID: C1CF09DFCE83	Ramp Type: Perp	Initial Pass/Fail: Fail	Overall Compliance: No
Severity Score: 8.75			
Codes/Mitigation Info/Possible Solution		Field Measurements/Component Compliance

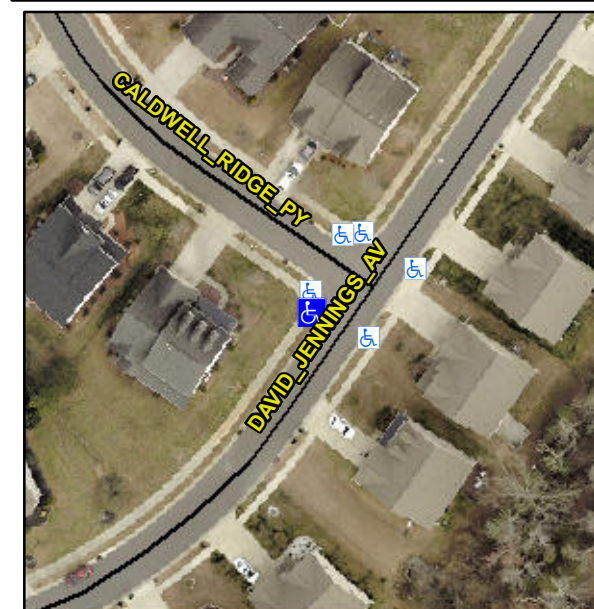
Not Found, R304.5.1

Compliance	Description	Data	Compliance	Description	Data
N/A	Ramp Length (in)	47.5	Yes	Ramp Slope (%)	7.5
No	Ramp Width (in)	43.5	Yes	Ramp XSlope (%)	1.9
N/A	Flare Type LT	N/A	N/A	Flare Type RT	N/A
N/A	Flare Slope LT (%)	N/A	N/A	Flare Slope RT (%)	N/A
N/A	Flare Traversable LT?	N/A	N/A	Flare Traversable RT?	N/A
N/A	Landing Length (in)	N/A	N/A	DWS Provided?	N/A
N/A	Landing Width (in)	N/A	N/A	DWS Contrast?	N/A
N/A	Landing Slope (%)	N/A	N/A	DWS Length (in)	N/A
N/A	Landing X Slope (%)	N/A	N/A	DWS Full Width?	N/A
N/A	Landing Curb? (Y/N)	N/A	N/A	DWS Offset (in)	N/A
N/A	Shared Landing?	N/A			
N/A	Gutter Ponding?	N/A	N/A	Gutter Slope (%)	N/A
N/A	Gutter Lip Ht (in)	0.5	N/A	Gutter X Slope (%)	N/A
N/A	Painted X Walk1?	No	N/A	Painted X Walk2?	N/A
	X Walk 1 Direction	To SE		X Walk 2 Direction	N/A
N/A	X Walk 1 Width (in)	N/A	N/A	X Walk 2 Width (in)	N/A
	X Walk 1 Slope (%)	0.7		X Walk 2 Slope (%)	N/A
	X Walk 1 X Slope (%)	2.0		X Walk 2 X Slope (%)	N/A

N/A	Ramp inside XWalk1?	N/A	N/A	Ramp inside XWalk2?	N/A
	Road Slope (%)	N/A	N/A	Clear Space?	N/A
	Road X Slope (%)	N/A	N/A	Clear Space to XWalk (in)	N/A
N/A	Any Obstructions?	N/A	N/A	Storm Grate/Utility Hazard?	N/A
	Obstruction Type			Storm Grate/Utility Type	
		N/A			N/A
			Yes	Surface Condition? (G/P)	Good

Remove & Replace Entire Ramp.

Total Cost: \$ 1850.00
