Access Compliance Report

Public Rights-of-Way

(Curb Ramps)

Intersection ID: 12017	Main Street: S I-77 EXIT 10A RA	Cross Street: W MOREHEAD ST	Location: NE
ADA ID: C1D1B3D34690	Ramp Type: Perp	Initial Pass/Fail: Fail	Overall Compliance: No
		Severity Score: 12.5

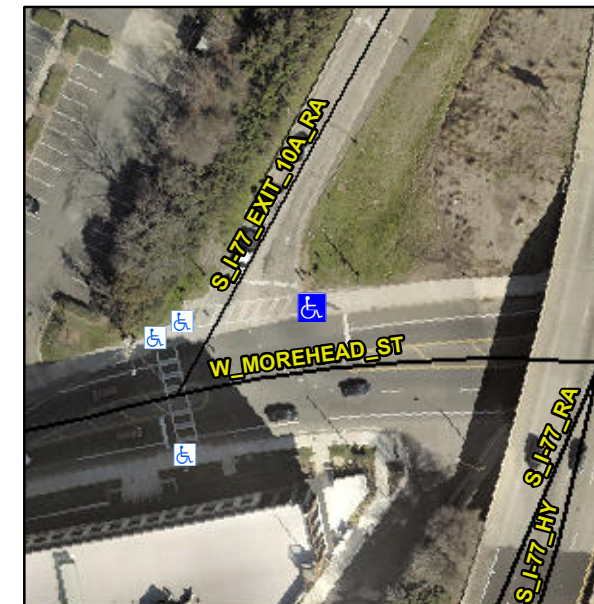
Not Found, R304.2.2

Compliance	Description	Data	Compliance	Description	Data
N/A	Ramp Length (in)	33.0	No	Ramp Slope (%)	8.4
Yes	Ramp Width (in)	69.0	Yes	Ramp XSlope (%)	1.1
N/A	Flare Type LT	N/A	N/A	Flare Type RT	N/A
N/A	Flare Slope LT (%)	N/A	N/A	Flare Slope RT (%)	N/A
N/A	Flare Traversable LT?	N/A	N/A	Flare Traversable RT?	N/A
N/A	Landing Length (in)	N/A	N/A	DWS Provided?	N/A
N/A	Landing Width (in)	N/A	N/A	DWS Contrast?	N/A
N/A	Landing Slope (%)	N/A	N/A	DWS Length (in)	N/A
N/A	Landing X Slope (%)	N/A	N/A	DWS Full Width?	N/A
N/A	Landing Curb? (Y/N)	N/A	N/A	DWS Offset (in)	N/A
N/A	Shared Landing?	N/A			
N/A	Gutter Ponding?	N/A	N/A	Gutter Slope (%)	N/A
N/A	Gutter Lip Ht (in)	N/A	N/A	Gutter X Slope (%)	N/A
N/A	Painted X Walk1?	No	N/A	Painted X Walk2?	N/A
	X Walk 1 Direction	To W		X Walk 2 Direction	N/A
N/A	X Walk 1 Width (in)	N/A	N/A	X Walk 2 Width (in)	N/A
	X Walk 1 Slope (%)	1.6		X Walk 2 Slope (%)	N/A
	X Walk 1 X Slope (%)	5.5		X Walk 2 X Slope (%)	N/A

N/A	Ramp inside XWalk1?	N/A	N/A	Ramp inside XWalk2?	N/A
	Road Slope (%)	N/A	N/A	Clear Space?	N/A
	Road X Slope (%)	N/A	N/A	Clear Space to XWalk (in)	N/A
N/A	Any Obstructions?	N/A	N/A	Storm Grate/Utility Hazard?	N/A
	Obstruction Type			Storm Grate/Utility Type	
		N/A			N/A
			Yes	Surface Condition? (G/P)	Good

Possible Solutions:

Remove & Replace Entire Ramp.

Total Cost: \$ 1850.00
