# Access Compliance Report

## Public Rights-of-Way

### (Curb Ramps)

| Intersection ID: 3423 | Main Street: OVERLOOK_MOUNTAIN_DR | Cross Street: SOLEMN_POINTE_LN | Location: NE |

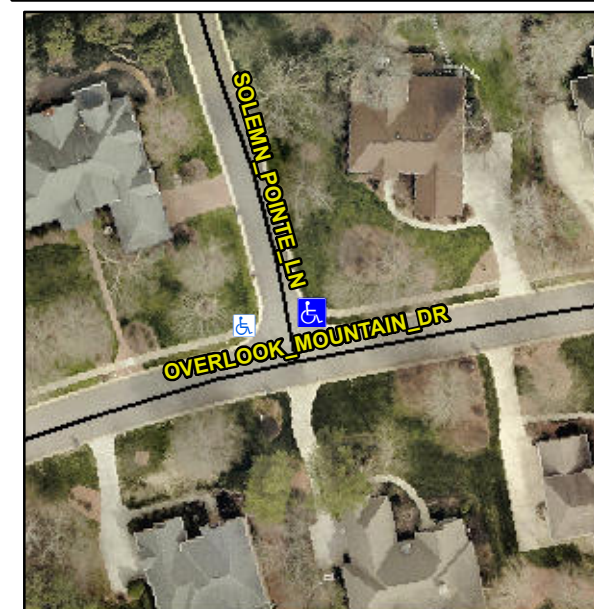
| ADA ID: C1D354263DD7 | Ramp Type: Perp | Initial Pass/Fail: Fail | Overall Compliance: No |
| Severity Score: 8.75 | | | |

**R304.5.1**

| Compliance | Description | Data | Compliance | Description | Data |
|---|---|---|---|---|---|
| No | Ramp Width (in) | 44.5 | Yes | Ramp XSlope (%) | 1.8 |

**Remove & Replace Entire Ramp.**

**\$ 1850.00**
