Access Compliance Report

Public Rights-of-Way

(Curb Ramps)

Intersection ID: 5609	Main Street: HAMILTON_CR	Cross Street: SUNSET_RD	Location: SE
ADA ID: C1DC843D721E	Ramp Type: Combination1Diag	Initial Pass/Fail: Fail	Overall Compliance: No
Severity Score: 0			
Codes/Mitigation Info/Possible Solution		Field Measurements/Component Compliance

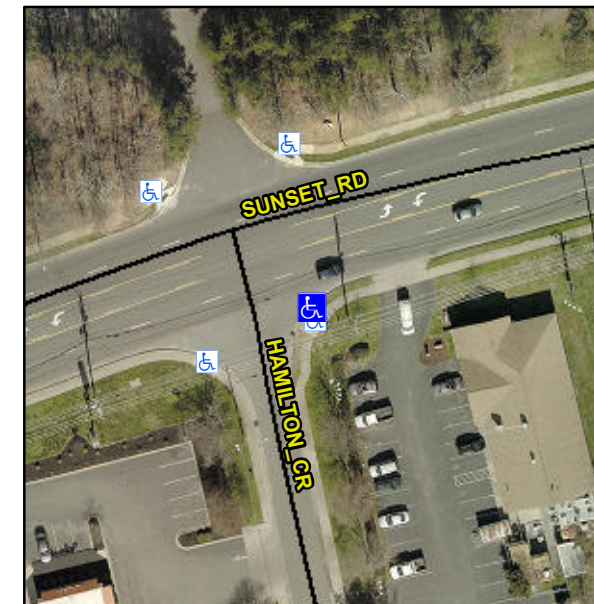
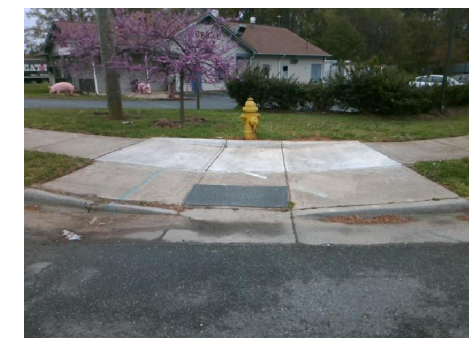
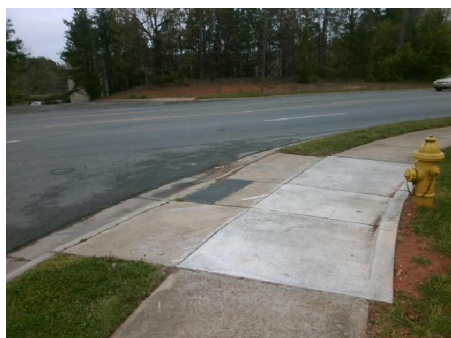
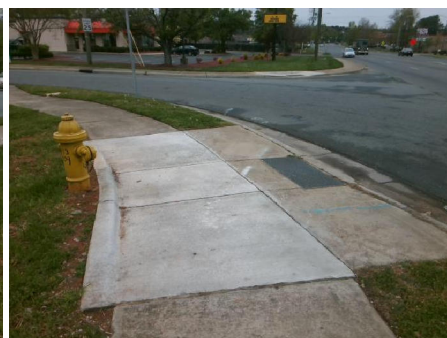
Not Found, R304.5.1

Compliance	Description	Data	Compliance	Description	Data
N/A	Ramp Length LT (in)	65.0	N/A	Ramp Length RT (in)	64.0
Yes	Ramp Width LT (in)	62.0	Yes	Ramp Width RT (in)	58.0
Yes	Ramp Slope LT (%)	7.4	Yes	Ramp Slope RT (%)	5.1
Yes	Ramp XSlope LT (%)	1.4	Yes	Ramp XSlope RT (%)	1.5
N/A	Ramp Length (in)	48.0	Yes	Ramp Slope (%)	6.3
No	Ramp Width (in)	44.5	Yes	Ramp XSlope (%)	0.1
N/A	Flare Type LT	N/A	N/A	Flare Type RT	N/A
N/A	Flare Slope LT (%)	N/A	N/A	Flare Slope RT (%)	N/A
N/A	Flare Traversable LT?	N/A	N/A	Flare Traversable RT?	N/A
N/A	Landing Length (in)	N/A	N/A	DWS Provided?	N/A
N/A	Landing Width (in)	N/A	N/A	DWS Contrast?	N/A
N/A	Landing Slope (%)	N/A	N/A	DWS Length (in)	N/A
N/A	Landing X Slope (%)	N/A	N/A	DWS Full Width?	N/A
N/A	Landing Curb? (Y/N)	N/A	N/A	DWS Offset (in)	N/A
N/A	Shared Landing?	N/A			
N/A	Gutter Ponding?	N/A	N/A	Gutter Slope (%)	N/A
N/A	Gutter Lip Ht (in)	N/A	N/A	Gutter X Slope (%)	N/A
N/A	Painted X Walk1?	No	N/A	Painted X Walk2?	No

X Walk 1 Direction	To N		X Walk 2 Direction	To W
	X Walk 1 Width (in)	N/A		X Walk 2 Width (in)	N/A
	X Walk 1 Slope (%)	1.1		X Walk 2 Slope (%)	0.3
	X Walk 1 X Slope (%)	0.5		X Walk 2 X Slope (%)	0.4
N/A	Ramp inside XWalk1?	N/A	N/A	Ramp inside XWalk2?	N/A
	Road Slope (%)	1.3		Clear Space?	N/A
	Road X Slope (%)	2.8	N/A	Clear Space to XWalk (in)	N/A
			N/A	Any Obstruction?	N/A
				Obstruction Type	N/A
			N/A	Storm Grate/Utility Hazard?	N/A
				Storm Grate/Utility Type	N/A
Yes	Surface Condition? (G/P)	Good			
	Curb Slope (%)	11.0

Remove & Replace Curb Ramp With Two New Directional Ramps or Equivalent.
