Access Compliance Report

Public Rights-of-Way

(Curb Ramps)

Intersection ID: 20567	Main Street: PARK_SOUTH_DR	Cross Street: PINE_VALLEY_RD	Location: NE
ADA ID: C1DE42F84DAF	Ramp Type: Directional	Initial Pass/Fail: Fail	Overall Compliance: No
		Severity Score: 12.5

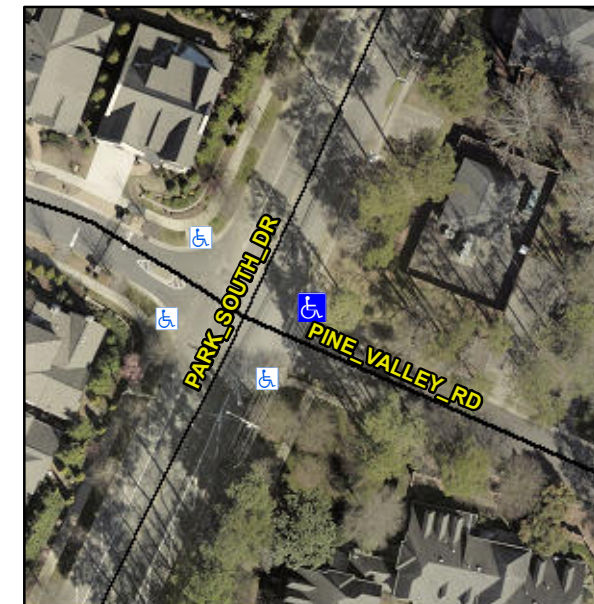
R304.5.3

Compliance	Description	Data	Compliance	Description	Data
N/A	Ramp Length (in)	25.0	N/A	Grade Break?	N/A
Yes	Ramp Width (in)	48.0	N/A	Grade Break Slope (%)	0.0
Yes	Ramp Slope (%)	2.6	N/A	Grade Break XSlope (%)	0.0
No	Ramp XSlope (%)	5.1			
N/A	Flare Type LT	N/A	N/A	Flare Type RT	N/A
N/A	Flare Slope LT (%)	N/A	N/A	Flare Slope RT (%)	0.0
N/A	Flare Traversable LT?	N/A	N/A	Flare Traversable RT?	N/A
N/A	Landing Length (in)	0.0	N/A	DWS Provided?	N/A
N/A	Landing Width (in)	0.0	N/A	DWS Contrast?	N/A
N/A	Landing Slope (%)	0.0	N/A	DWS Length (in)	N/A
N/A	Landing X Slope (%)	0.0	N/A	DWS Full Width?	N/A
N/A	Landing Curb? (Y/N)	N/A	N/A	DWS Offset LT (in)	N/A
N/A	Shared Landing?	N/A	N/A	DWS Offset RT (in)	N/A
N/A	Gutter Ponding?	0.0	N/A	Gutter Slope (%)	N/A
N/A	Gutter Lip Ht (in)	0.0	N/A	Gutter X Slope (%)	N/A
N/A	Painted X Walk1?	No		Road Slope (%)	4.9
	X Walk 1 Direction	To S		Road X Slope (%)	3.4
	X Walk 1 Width (in)	N/A		Clear Space?	N/A

X Walk 1 Slope (%)	4.9	N/A	Clear Space to XWalk (in)	N/A
	X Walk 1 X Slope (%)	3.4	N/A	Storm Grate/Utility Hazard?	N/A
N/A	Ramp inside XWalk1?	N/A		Storm Grate/Utility Type	
N/A	Any Obstructions?	N/A			N/A
	Obstruction Type		Yes	Surface Condition? (G/P)	Good
			N/A	Curb Slope (%)	18.3

Remove & Replace Entire Ramp.
