# Access Compliance Report

## Public Rights-of-Way

### (Curb Ramps)

Intersection ID: 31712	Main Street: ALDER_CT	Cross Street: BUTTONWOOD_CT	Location:	N
ADA ID: C1DF8BCC50FF	Ramp Type: PerpDiag	Initial Pass/Fail: Fail	Overall Compliance: No	Severity Score: 13.75
Codes/Mitigation Info/Possible Solution		Field Measurements/Component Compliance

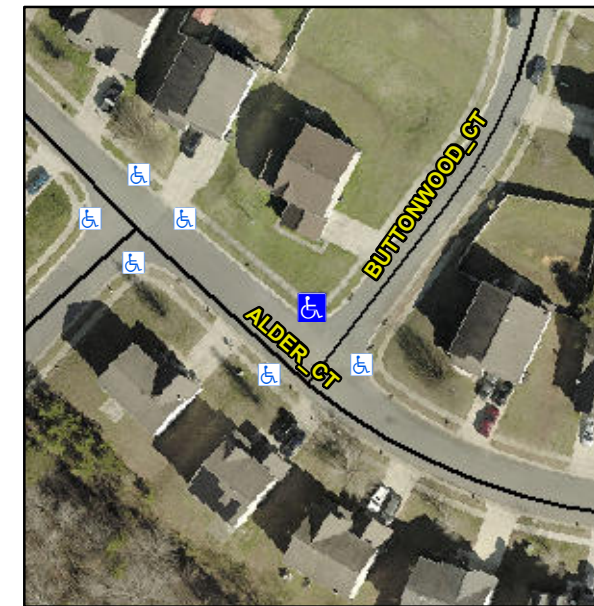
**Not Found, R304.2.2, R304.5.3**

Compliance	Description	Data	Compliance	Description	Data
N/A	Ramp Length (in)	48.0	No	Ramp Slope (%)	9.3
Yes	Ramp Width (in)	48.0	No	Ramp XSlope (%)	3.9
N/A	Flare Type LT	N/A	N/A	Flare Type RT	N/A
N/A	Flare Slope LT (%)	N/A	N/A	Flare Slope RT (%)	N/A
N/A	Flare Traversable LT?	N/A	N/A	Flare Traversable RT?	N/A
N/A	Landing Length (in)	N/A	N/A	DWS Provided?	N/A
N/A	Landing Width (in)	N/A	N/A	DWS Contrast?	N/A
N/A	Landing Slope (%)	N/A	N/A	DWS Length (in)	N/A
N/A	Landing X Slope (%)	N/A	N/A	DWS Full Width?	N/A
N/A	Landing Curb? (Y/N)	N/A	N/A	DWS Offset (in)	N/A
N/A	Shared Landing?	N/A			
N/A	Gutter Ponding?	N/A	N/A	Gutter Slope (%)	N/A
N/A	Gutter Lip Ht (in)	N/A	N/A	Gutter X Slope (%)	N/A
N/A	Painted X Walk1?	No	N/A	Painted X Walk2?	No
	X Walk 1 Direction	To SW		X Walk 2 Direction	To SE
N/A	X Walk 1 Width (in)	N/A	N/A	X Walk 2 Width (in)	N/A
	X Walk 1 Slope (%)	0.2		X Walk 2 Slope (%)	4.7
	X Walk 1 X Slope (%)	5.3		X Walk 2 X Slope (%)	2.1

N/A	Ramp inside XWalk1?	N/A	N/A	Ramp inside XWalk2?	N/A
	Road Slope (%)	4.5	N/A	Clear Space?	N/A
	Road X Slope (%)	5.2	N/A	Clear Space to XWalk (in)	N/A
N/A	Any Obstructions?	N/A	N/A	Storm Grate/Utility Hazard?	N/A
	Obstruction Type			Storm Grate/Utility Type	
		N/A			N/A
			Yes	Surface Condition? (G/P)	Good

Possible Solutions:

**Remove & Replace Curb Ramp With Two New Directional Ramps or Equivalent.**
