Intersection ID: 7207	Main Street: HOPE_VALLEY_LN	Cross Street: KINGVILLE_DR	Location:	W
ADA ID: C1E31040BB08	Ramp Type: BlendTrans1	Initial Pass/Fail: Fail	Overall Compliance: No	Severity Score: 21.25

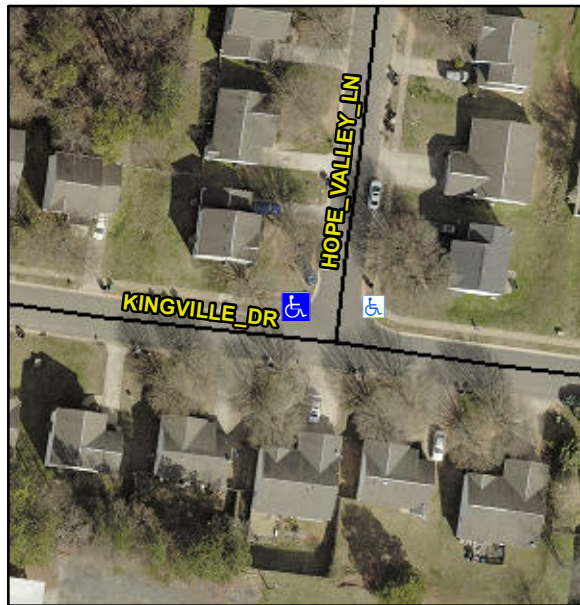
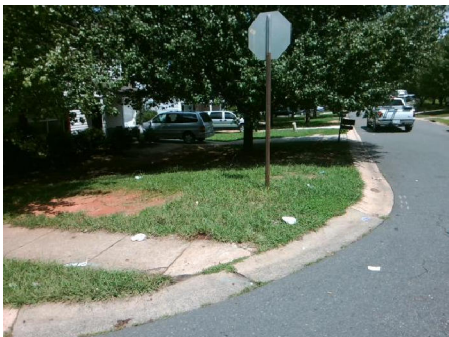
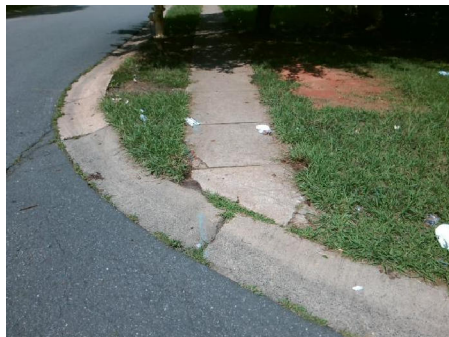
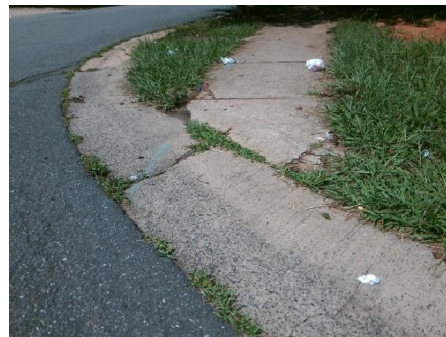
Compliance	Description	Data	Compliance	Description	Data
N/A	Ramp Length (in)	12.0	Yes	BlendTrans Slope (%)	0.5
No	Ramp Width (in)	42.0	No	BlendTrans XSlope (%)	5.8
N/A	Flare Type LT	N/A	N/A	Flare Type RT	N/A
N/A	Flare Slope LT (%)	N/A	N/A	Flare Slope RT (%)	N/A
N/A	Flare Traversable LT?	N/A	N/A	Flare Traversable RT?	N/A
N/A	Landing Length (in)	N/A	N/A	DWS Provided?	N/A
N/A	Landing Width (in)	N/A	N/A	DWS Contrast?	N/A
N/A	Landing Slope (%)	N/A	N/A	DWS Length (in)	N/A
N/A	Landing X Slope (%)	N/A	N/A	DWS Full Width?	N/A
N/A	Landing Curb? (Y/N)	N/A	N/A	DWS Offset (in)	N/A
N/A	Shared Landing?	N/A			
N/A	Gutter Ponding?	N/A	N/A	Gutter Slope (%)	N/A
N/A	Gutter Lip Ht (in)	1.0	N/A	Gutter X Slope (%)	N/A
N/A	Painted X Walk1?	No	N/A	Painted X Walk2?	N/A
	X Walk 1 Direction	To E		X Walk 2 Direction	N/A
	X Walk 1 Width (in)	N/A		X Walk 2 Width (in)	N/A
	X Walk 1 Slope (%)	8.2		X Walk 2 Slope (%)	N/A
	X Walk 1 X Slope (%)	2.9		X Walk 2 X Slope (%)	N/A

N/A	Ramp inside XWalk1?	N/A	N/A	Ramp inside XWalk2?	N/A
	Road Slope (%)	2.9		Clear Space?	N/A
	Road X Slope (%)	8.2	N/A	Clear Space to XWalk (in)	N/A
N/A	Any Obstructions?	N/A	N/A	Storm Grate/Utility Hazard?	N/A
	Obstruction Type			Storm Grate/Utility Type	
		N/A			N/A
			Yes	Surface Condition? (G/P)	Good
			N/A	Curb Slope (%)	1.6

Remove & Replace Curb Ramp With Two New Directional Ramps or Equivalent.
