# Access Compliance Report

## Public Rights-of-Way

### (Curb Ramps)

Intersection ID: 10205	Main Street: STATESVILLE_AV	Cross Street: OAKLAWN_AV	Location: NE
ADA ID: C1F0A5AAE474	Ramp Type: Perp	Initial Pass/Fail: Fail	Overall Compliance: No
		Severity Score: 12.5

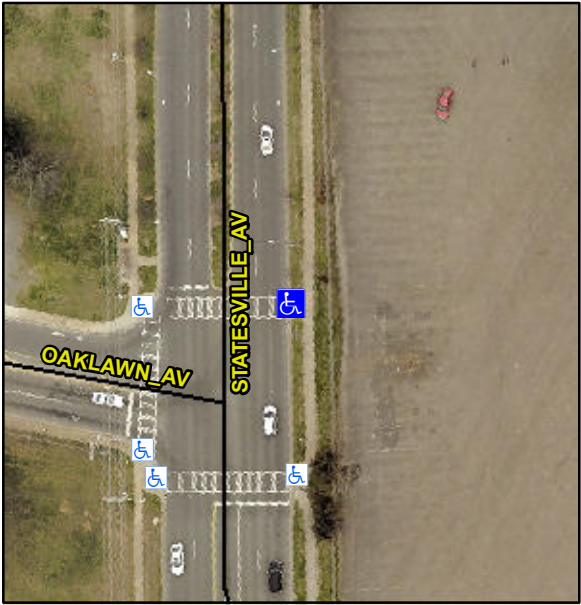
Possible Solutions:		<b>Compliance</b>	<b>Description</b>	<b>Data</b>
	<b>Remove &amp; Replace Entire Ramp.</b>		<b>No</b>	Ramp Length (in)	71.5
			<b>Yes</b>	Ramp Width (in)	48.0
			<b>N/A</b>	Flare Type LT	N/A
			<b>N/A</b>	Flare Slope LT (%)	N/A
			<b>N/A</b>	Flare Traversable LT?	N/A
			<b>N/A</b>	Landing Length (in)	N/A
			<b>N/A</b>	Landing Width (in)	N/A
			<b>N/A</b>	Landing Slope (%)	N/A
			<b>N/A</b>	Landing X Slope (%)	N/A
<p>Surveyor Notes:</p> <p><b>N/A</b></p> <p>PROW/ADA:</p> <p><b>Not Found, R304.2.2</b></p>			<b>N/A</b>	Flare Type RT	N/A
			<b>N/A</b>	Flare Slope RT (%)	N/A
			<b>N/A</b>	Flare Traversable RT?	N/A
			<b>N/A</b>	DWS Provided?	N/A
			<b>N/A</b>	DWS Contrast?	N/A
			<b>N/A</b>	DWS Length (in)	N/A
			<b>N/A</b>	DWS Full Width?	N/A
			<b>N/A</b>	DWS Offset (in)	N/A
			<b>N/A</b>	Shared Landing?	N/A

<b>N/A</b>	Gutter Ponding?	N/A
			<b>N/A</b>	Gutter Lip Ht (in)	N/A
			<b>N/A</b>	Painted X Walk1?	Yes
				X Walk 1 Direction	To W
			<b>N/A</b>	X Walk 1 Width (in)	119.0
				X Walk 1 Slope (%)	2.2
				X Walk 1 X Slope (%)	0.1
			<b>N/A</b>	Ramp inside XWalk1?	Yes
			<b>N/A</b>	Road Slope (%)	N/A
			<b>N/A</b>	Road X Slope (%)	N/A
			<b>N/A</b>	Any Obstructions?	N/A
				Obstruction Type	
			<b>N/A</b>		
			<b>N/A</b>		
			<b>N/A</b>		
			<b>N/A</b>		
			<b>N/A</b>		
			<b>N/A</b>		
			<b>N/A</b>		
			<b>N/A</b>		
			<b>N/A</b>		
Total Cost:		\$ 1850.00			
			<b>N/A</b>		
			<b>Yes</b>	Surface Condition? (G/P)	Good
