## Access Compliance Report Public Rights-of-Way (Curb Ramps)

Intersection ID: 15254 Main Street: IDEAL_WY Cross Street: PARK_RD								Loostion	05
Intersection ID: 15254	Main Street: IDEAL_WY		Cross	Street:	PARK_RD	Location:	SE		
ADA ID: C1F521FFECE3	E3 Ramp Type: PerpDiag			Initial Pass/Fail: Fail Overall Compliance: No				o Severity Score:	13.75
Codes/Mitigation Info/Possible Solution				Field Measurements/Component Compliance					
the second se	R	Possible Solutions:		Compliance Description Data Comp			liance Description	Data

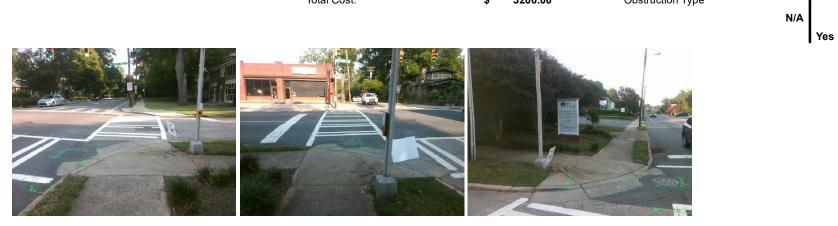
- INCLUM		Remove & Replace Curb Ramp	With	N/A	Ramp Length (in)	70.0	No	Ramp Slope (%)	8.6
		Two New Directional Ramps or		Yes	Ramp Width (in)	71.0	No	Ramp XSlope (%)	2.3
The Part		Equivalent.		N/A	Flare Type LT	N/A	N/A	Flare Type RT	N/A
A KIN				N/A	Flare Slope LT (%)	N/A	N/A	Flare Slope RT (%)	N/A
				N/A	Flare Traversable LT?	N/A	N/A	Flare Traversable RT?	N/A
the second se				N/A	Landing Length (in)	N/A	N/A	DWS Provided?	N/A

C. to C. L.	- PARTICIPAL	PROW/ADA:		N/A	Gutter Ponding?	N/A	N/A	Gutter Slope (%)	N/A
0	840	Not Found, R304.2.2, R304.5.3		N/A	Gutter Lip Ht (in)	N/A	N/A	Gutter X Slope (%)	N/A
		,,		N/A	Painted X Walk1?	Yes	N/A	Painted X Walk2?	Yes
				X Walk 1 Direction	To N		X Walk 2 Direction	To W	
	and the second			N/A	X Walk 1 Width (in)	107.0	N/A	X Walk 2 Width (in)	108.0
Street 1 Name	IDEAL WY				X Walk 1 Slope (%)	6.4		X Walk 2 Slope (%)	6.1
Stop Condition-Street 2	Signal				X Walk 1 X Slope (%)	1.3		X Walk 2 X Slope (%)	4.2
Street 2 Name	PARK RD			N/A	Ramp inside XWalk1?	Yes	N/A	Ramp inside XWalk2?	Yes
Stop Condition-Street 1	Signal				Road Slope (%)	0.8	N/A	Clear Space?	N/A
