# Access Compliance Report

## Public Rights-of-Way

### (Curb Ramps)

Intersection ID: N/A	Main Street: MAYFLOWER_RD	Cross Street: NORMA_ST	Location: NW
ADA ID: C1FA3D520F81	Ramp Type: Directional	Initial Pass/Fail: Fail	Overall Compliance: No
Codes/Mitigation Info/Possible Solution		Field Measurements/Component Compliance	
Severity Score: 13.75

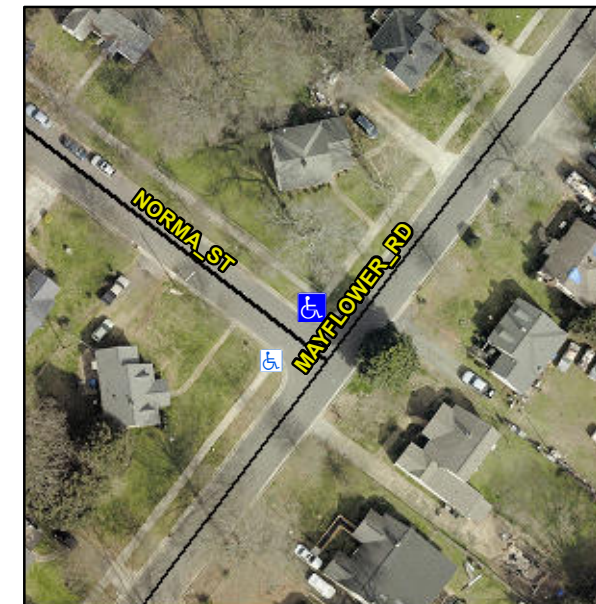
**R304.2.2, R304.5.3**

Compliance	Description	Data	Compliance	Description	Data
N/A	Ramp Length (in)	84.0	N/A	Grade Break?	N/A
Yes	Ramp Width (in)	56.0	N/A	Grade Break Slope (%)	0.0
No	Ramp Slope (%)	8.4	N/A	Grade Break XSlope (%)	0.0
No	Ramp XSlope (%)	2.4			
N/A	Flare Type LT	N/A	N/A	Flare Type RT	N/A
N/A	Flare Slope LT (%)	N/A	N/A	Flare Slope RT (%)	0.0
N/A	Flare Traversable LT?	N/A	N/A	Flare Traversable RT?	N/A
N/A	Landing Length (in)	0.0	N/A	DWS Provided?	N/A
N/A	Landing Width (in)	0.0	N/A	DWS Contrast?	N/A
N/A	Landing Slope (%)	0.0	N/A	DWS Length (in)	N/A
N/A	Landing X Slope (%)	0.0	N/A	DWS Full Width?	N/A
N/A	Landing Curb? (Y/N)	N/A	N/A	DWS Offset LT (in)	N/A
N/A	Shared Landing?	N/A	N/A	DWS Offset RT (in)	N/A
N/A	Gutter Ponding?	0.0	N/A	Gutter Slope (%)	N/A
N/A	Gutter Lip Ht (in)	0.0	N/A	Gutter X Slope (%)	N/A
N/A	Painted X Walk1?	No		Road Slope (%)	2.7
	X Walk 1 Direction	To S		Road X Slope (%)	1.2
	X Walk 1 Width (in)	N/A		Clear Space?	N/A

X Walk 1 Slope (%)	2.7	N/A	Clear Space to XWalk (in)	N/A
	X Walk 1 X Slope (%)	1.2	N/A	Storm Grate/Utility Hazard?	N/A
N/A	Ramp inside XWalk1?	N/A		Storm Grate/Utility Type	
N/A	Any Obstructions?	N/A			N/A
	Obstruction Type		Yes	Surface Condition? (G/P)	Good
			N/A	Curb Slope (%)	0.5

**Remove & Replace Entire Ramp.**
