Access Compliance Report Public Rights-of-Way (Curb Ramps)

Intersection ID: 28243 Main Street: PINE_VALLEY_CLUB_DR Cross Street: ROYAL_BIRKDALE_CT Location: **ADA ID: C1FB4B3B50B8** Ramp Type: PerpDiag Initial Pass/Fail: Fail **Overall Compliance: No** Severity Score: 13.75

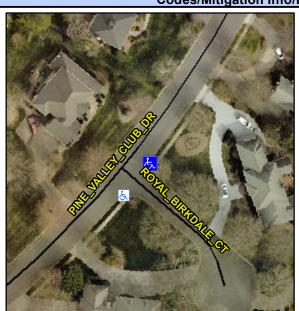
| Field Measurements/Component Compliance | | | | | |
|---|---|---|---|---|---|
| N/A | Ramp Length (in) | 64.0 | No | Ramp Slope (%) | 11.0 |
| Yes | Ramp Width (in) | 48.0 | No | Ramp XSlope (%) | 3.3 |

Possible Solutions: **Remove & Replace Curb Ramp With** Two New Directional Ramps or Equivalent. Surveyor Notes: N/A PROW/ADA: Not Found, R304.2.2, R304.5.3
