Access Compliance Report

Public Rights-of-Way

(Curb Ramps)

Intersection ID: 28211	Main Street: AUTUMN_APPLAUSE_DR	Cross Street: STAGS_LEAP_CT	Location:	SW
ADA ID: C1FF8C92FCC4	Ramp Type: BlendTrans2	Initial Pass/Fail: Fail	Overall Compliance: No	Severity Score: 30
Codes/Mitigation Info/Possible Solution		Field Measurements/Component Compliance

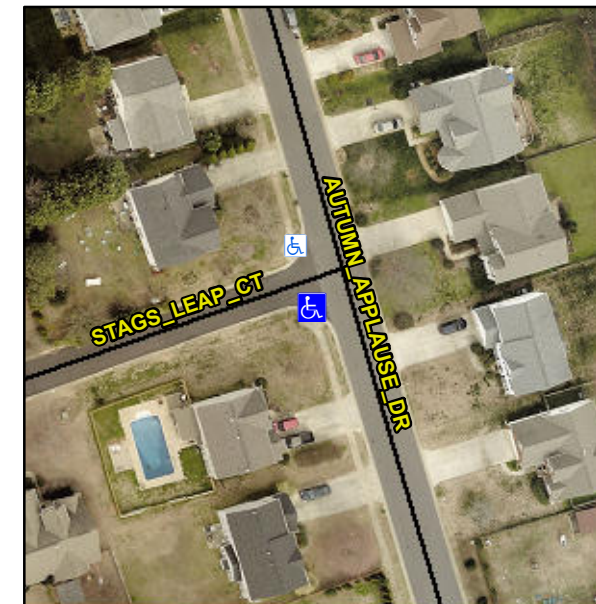
Compliance	Description	Data	Compliance	Description	Data
N/A	Ramp Length (in)	95.0	Yes	BlendTrans Slope (%)	2.9
No	Ramp Width (in)	34.0	No	BlendTrans XSlope (%)	6.0
N/A	Flare Type LT	N/A	N/A	Flare Type RT	N/A
N/A	Flare Slope LT (%)	N/A	N/A	Flare Slope RT (%)	N/A
N/A	Flare Traversable LT?	N/A	N/A	Flare Traversable RT?	N/A
N/A	Landing Length (in)	N/A	N/A	DWS Provided?	N/A
N/A	Landing Width (in)	N/A	N/A	DWS Contrast?	N/A
N/A	Landing Slope (%)	N/A	N/A	DWS Length (in)	N/A
N/A	Landing X Slope (%)	N/A	N/A	DWS Full Width?	N/A
N/A	Landing Curb? (Y/N)	N/A	N/A	DWS Offset (in)	N/A
N/A	Shared Landing?	N/A			
N/A	Gutter Ponding?	N/A	N/A	Gutter Slope (%)	N/A
N/A	Gutter Lip Ht (in)	N/A	N/A	Gutter X Slope (%)	N/A
N/A	Painted X Walk1?	No	N/A	Painted X Walk2?	No
	X Walk 1 Direction	To SE		X Walk 2 Direction	To NE
	X Walk 1 Width (in)	N/A		X Walk 2 Width (in)	N/A
	X Walk 1 Slope (%)	3.5		X Walk 2 Slope (%)	3.3
	X Walk 1 X Slope (%)	2.1		X Walk 2 X Slope (%)	1.2

N/A	Ramp inside XWalk1?	N/A	N/A	Ramp inside XWalk2?	N/A
	Road Slope (%)	3.1		Clear Space?	N/A
	Road X Slope (%)	0.8	N/A	Clear Space to XWalk (in)	N/A
N/A	Any Obstructions?	N/A	N/A	Storm Grate/Utility Hazard?	N/A
	Obstruction Type			Storm Grate/Utility Type	
		N/A			N/A
			Yes	Surface Condition? (G/P)	Good
			N/A	Curb Slope (%)	2.7

Possible Solutions:

Remove & Replace Curb Ramp With Two New Directional Ramps or Equivalent.

R304.5.1, R304.5.3

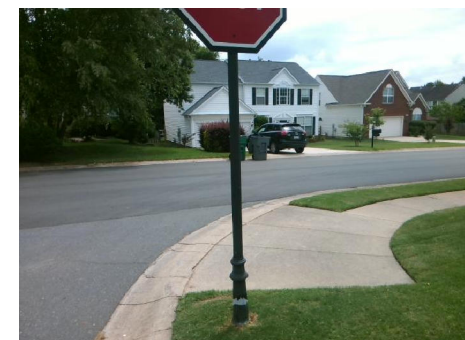
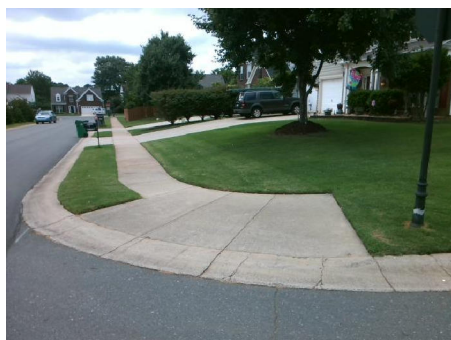
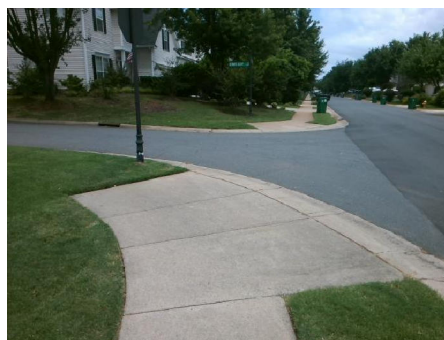
Street 1 Name AUTUMN APPLAUSE DR
 Stop Condition-Street 1 None
 Street 2 Name STAGS LEAP CT
 Stop Condition-Street 2 StopSign
