# Access Compliance Report

## Public Rights-of-Way

### (Curb Ramps)

Intersection ID: 9362	Main Street: DELTA_LAKE_DR	Cross Street: ROCKMOOR_RIDGE_RD	Location: SW
ADA ID: C20CD664D8FA	Ramp Type: BlendTrans1	Initial Pass/Fail: Fail	Overall Compliance: No
		Severity Score: 8.75

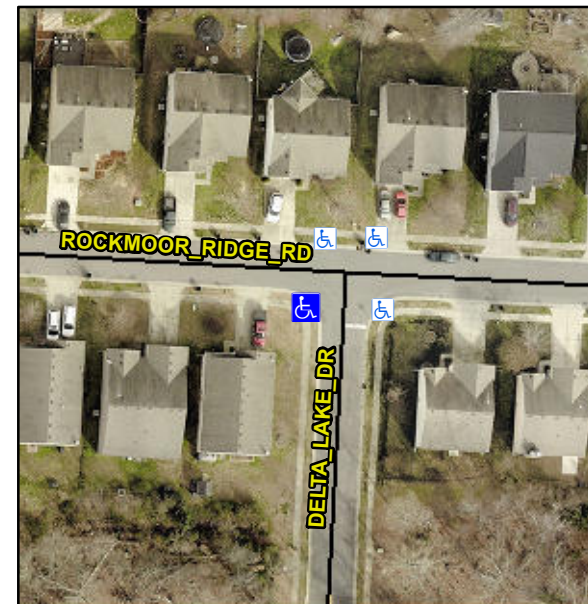
**CURB LIP 1.5**

**Not Found, R304.5.1**

Compliance	Description	Data	Compliance	Description	Data
N/A	Ramp Length (in)	48.5	Yes	BlendTrans Slope (%)	4.5
No	Ramp Width (in)	47.0	Yes	BlendTrans XSlope (%)	1.7
N/A	Flare Type LT	N/A	N/A	Flare Type RT	N/A
N/A	Flare Slope LT (%)	N/A	N/A	Flare Slope RT (%)	N/A
N/A	Flare Traversable LT?	N/A	N/A	Flare Traversable RT?	N/A
N/A	Landing Length (in)	N/A	N/A	DWS Provided?	N/A
N/A	Landing Width (in)	N/A	N/A	DWS Contrast?	N/A
N/A	Landing Slope (%)	N/A	N/A	DWS Length (in)	N/A
N/A	Landing X Slope (%)	N/A	N/A	DWS Full Width?	N/A
N/A	Landing Curb? (Y/N)	N/A	N/A	DWS Offset (in)	N/A
N/A	Shared Landing?	N/A			
N/A	Gutter Ponding?	N/A	N/A	Gutter Slope (%)	N/A
N/A	Gutter Lip Ht (in)	N/A	N/A	Gutter X Slope (%)	N/A
N/A	Painted X Walk1?	No	N/A	Painted X Walk2?	No
	X Walk 1 Direction	To N		X Walk 2 Direction	To E
	X Walk 1 Width (in)	N/A		X Walk 2 Width (in)	N/A
	X Walk 1 Slope (%)	1.0		X Walk 2 Slope (%)	3.4
	X Walk 1 X Slope (%)	1.7		X Walk 2 X Slope (%)	3.2

N/A	Ramp inside XWalk1?	N/A	N/A	Ramp inside XWalk2?	N/A
	Road Slope (%)	1.5		Clear Space?	N/A
	Road X Slope (%)	3.8	N/A	Clear Space to XWalk (in)	N/A
N/A	Any Obstructions?	N/A	N/A	Storm Grate/Utility Hazard?	N/A
	Obstruction Type			Storm Grate/Utility Type	
		N/A			N/A
			Yes	Surface Condition? (G/P)	Good
			No	Curb Slope (%)	11.2

**Remove & Replace Curb Ramp With Two New Directional Ramps or Equivalent.**
