# Access Compliance Report

## Public Rights-of-Way

### (Curb Ramps)

Intersection ID: 50587	Main Street: DOWNY_BIRCH_RD	Cross Street: GREAT_LAUREL_RD	Location: NW
ADA ID: C2122ABE3C78	Ramp Type: BlendTrans1	Initial Pass/Fail: Fail	Overall Compliance: No
Severity Score: 8.75			
Codes/Mitigation Info/Possible Solution		Field Measurements/Component Compliance

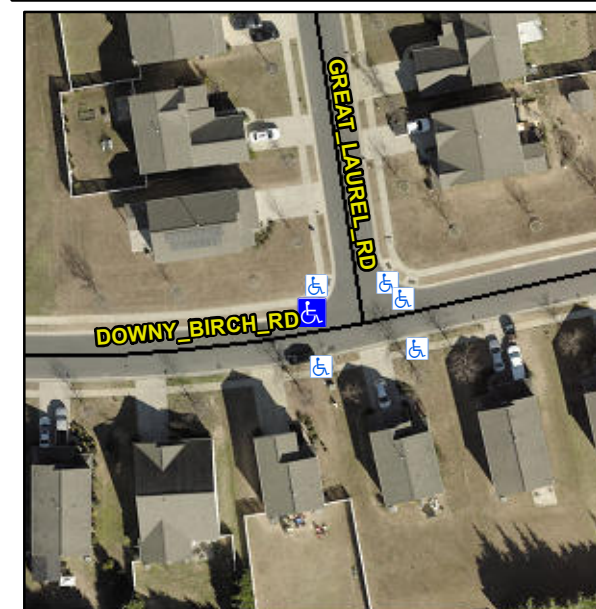
Compliance	Description	Data	Compliance	Description	Data
N/A	Ramp Length (in)	49.0	Yes	BlendTrans Slope (%)	3.9
No	Ramp Width (in)	45.5	Yes	BlendTrans XSlope (%)	0.0
N/A	Flare Type LT	N/A	N/A	Flare Type RT	N/A
N/A	Flare Slope LT (%)	N/A	N/A	Flare Slope RT (%)	N/A
N/A	Flare Traversable LT?	N/A	N/A	Flare Traversable RT?	N/A
N/A	Landing Length (in)	N/A	N/A	DWS Provided?	N/A
N/A	Landing Width (in)	N/A	N/A	DWS Contrast?	N/A
N/A	Landing Slope (%)	N/A	N/A	DWS Length (in)	N/A
N/A	Landing X Slope (%)	N/A	N/A	DWS Full Width?	N/A
N/A	Landing Curb? (Y/N)	N/A	N/A	DWS Offset (in)	N/A
N/A	Shared Landing?	N/A			
N/A	Gutter Ponding?	N/A	N/A	Gutter Slope (%)	N/A
N/A	Gutter Lip Ht (in)	N/A	N/A	Gutter X Slope (%)	N/A
N/A	Painted X Walk1?	No	N/A	Painted X Walk2?	N/A
	X Walk 1 Direction	To S		X Walk 2 Direction	N/A
	X Walk 1 Width (in)	N/A		X Walk 2 Width (in)	N/A
	X Walk 1 Slope (%)	2.8		X Walk 2 Slope (%)	N/A
	X Walk 1 X Slope (%)	1.4		X Walk 2 X Slope (%)	N/A

N/A	Ramp inside XWalk1?	N/A	N/A	Ramp inside XWalk2?	N/A
	Road Slope (%)	1.4		Clear Space?	N/A
	Road X Slope (%)	2.8	N/A	Clear Space to XWalk (in)	N/A
N/A	Any Obstructions?	N/A	N/A	Storm Grate/Utility Hazard?	N/A
	Obstruction Type			Storm Grate/Utility Type	
		N/A			N/A
			Yes	Surface Condition? (G/P)	Good
			No	Curb Slope (%)	8.0

**Remove & Replace Curb Ramp With Two New Directional Ramps or Equivalent.**

**Not Found, R304.5.1**
