Access Compliance Report

Public Rights-of-Way

(Curb Ramps)

Intersection ID: 27478	Main Street: BALLANTYNE_MEADOWS_DR	Cross Street: BLUE_CEDAR_LN	Location: SW
ADA ID: C213DEE70EB5	Ramp Type: PerpDiag	Initial Pass/Fail: Fail	Overall Compliance: No
		Severity Score: 37.5	
Codes/Mitigation Info/Possible Solution		Field Measurements/Component Compliance

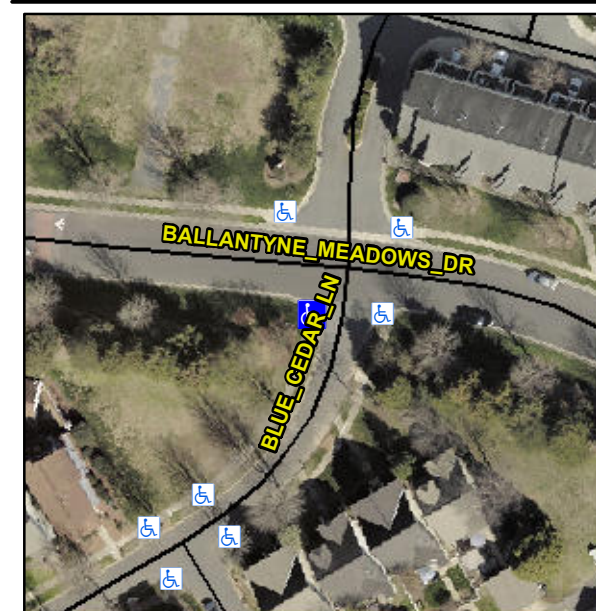
Compliance	Description	Data	Compliance	Description	Data
N/A	Ramp Length (in)	60.0	No	Ramp Slope (%)	11.8
Yes	Ramp Width (in)	48.0	No	Ramp XSlope (%)	7.0
N/A	Flare Type LT	N/A	N/A	Flare Type RT	N/A
N/A	Flare Slope LT (%)	N/A	N/A	Flare Slope RT (%)	N/A
N/A	Flare Traversable LT?	N/A	N/A	Flare Traversable RT?	N/A
N/A	Landing Length (in)	N/A	N/A	DWS Provided?	N/A
N/A	Landing Width (in)	N/A	N/A	DWS Contrast?	N/A
N/A	Landing Slope (%)	N/A	N/A	DWS Length (in)	N/A
N/A	Landing X Slope (%)	N/A	N/A	DWS Full Width?	N/A
N/A	Landing Curb? (Y/N)	N/A	N/A	DWS Offset (in)	N/A
N/A	Shared Landing?	N/A			
N/A	Gutter Ponding?	N/A	N/A	Gutter Slope (%)	N/A
N/A	Gutter Lip Ht (in)	N/A	N/A	Gutter X Slope (%)	N/A
N/A	Painted X Walk1?	No	N/A	Painted X Walk2?	No
	X Walk 1 Direction	To E		X Walk 2 Direction	To N
N/A	X Walk 1 Width (in)	N/A	N/A	X Walk 2 Width (in)	N/A
	X Walk 1 Slope (%)	3.8		X Walk 2 Slope (%)	2.0
	X Walk 1 X Slope (%)	3.4		X Walk 2 X Slope (%)	5.0

N/A	Ramp inside XWalk1?	N/A	N/A	Ramp inside XWalk2?	N/A
	Road Slope (%)	4.3	N/A	Clear Space?	N/A
	Road X Slope (%)	2.8	N/A	Clear Space to XWalk (in)	N/A
N/A	Any Obstructions?	N/A	N/A	Storm Grate/Utility Hazard?	N/A
	Obstruction Type			Storm Grate/Utility Type	
		N/A			N/A
		Yes		Surface Condition? (G/P)	Good

Remove & Replace Curb Ramp With Two New Directional Ramps or Equivalent.
