Access Compliance Report

Public Rights-of-Way

(Curb Ramps)

Intersection ID: 50602	Main Street: RHODORA_RD	Cross Street: CEDARFIELD_RD	Location: NE
ADA ID: C21D652790EF	Ramp Type: Perp	Initial Pass/Fail: Fail	Overall Compliance: No
Severity Score: 22.5			
Codes/Mitigation Info/Possible Solution		Field Measurements/Component Compliance

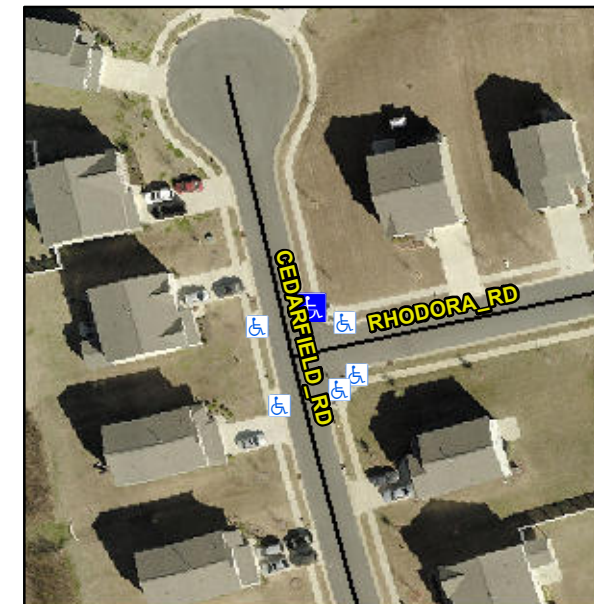
Not Found, R304.5.1, R304.2.2

Compliance	Description	Data	Compliance	Description	Data
N/A	Ramp Length (in)	48.0	No	Ramp Slope (%)	9.5
No	Ramp Width (in)	47.0	Yes	Ramp XSlope (%)	3.4
N/A	Flare Type LT	N/A	N/A	Flare Type RT	N/A
N/A	Flare Slope LT (%)	N/A	N/A	Flare Slope RT (%)	N/A
N/A	Flare Traversable LT?	N/A	N/A	Flare Traversable RT?	N/A
N/A	Landing Length (in)	N/A	N/A	DWS Provided?	N/A
N/A	Landing Width (in)	N/A	N/A	DWS Contrast?	N/A
N/A	Landing Slope (%)	N/A	N/A	DWS Length (in)	N/A
N/A	Landing X Slope (%)	N/A	N/A	DWS Full Width?	N/A
N/A	Landing Curb? (Y/N)	N/A	N/A	DWS Offset (in)	N/A
N/A	Shared Landing?	N/A			
N/A	Gutter Ponding?	N/A	N/A	Gutter Slope (%)	N/A
N/A	Gutter Lip Ht (in)	N/A	N/A	Gutter X Slope (%)	N/A
N/A	Painted X Walk1?	No	N/A	Painted X Walk2?	N/A
	X Walk 1 Direction	To W		X Walk 2 Direction	N/A
N/A	X Walk 1 Width (in)	N/A	N/A	X Walk 2 Width (in)	N/A
	X Walk 1 Slope (%)	2.9		X Walk 2 Slope (%)	N/A
	X Walk 1 X Slope (%)	4.2		X Walk 2 X Slope (%)	N/A

N/A	Ramp inside XWalk1?	N/A	N/A	Ramp inside XWalk2?	N/A
	Road Slope (%)	4.2	N/A	Clear Space?	N/A
	Road X Slope (%)	2.9	N/A	Clear Space to XWalk (in)	N/A
N/A	Any Obstructions?	N/A	N/A	Storm Grate/Utility Hazard?	N/A
	Obstruction Type			Storm Grate/Utility Type	
		N/A			N/A
			Yes	Surface Condition? (G/P)	Good

Possible Solutions:

Remove & Replace Entire Ramp.
