Access Compliance Report

Public Rights-of-Way

(Curb Ramps)

Intersection ID: 12073	Main Street: E_11TH_ST	Cross Street: N_CALDWELL_ST	Location: S
ADA ID: C24323C31C09	Ramp Type: PerpDiag	Initial Pass/Fail: Fail	Overall Compliance: No
		Severity Score: 10

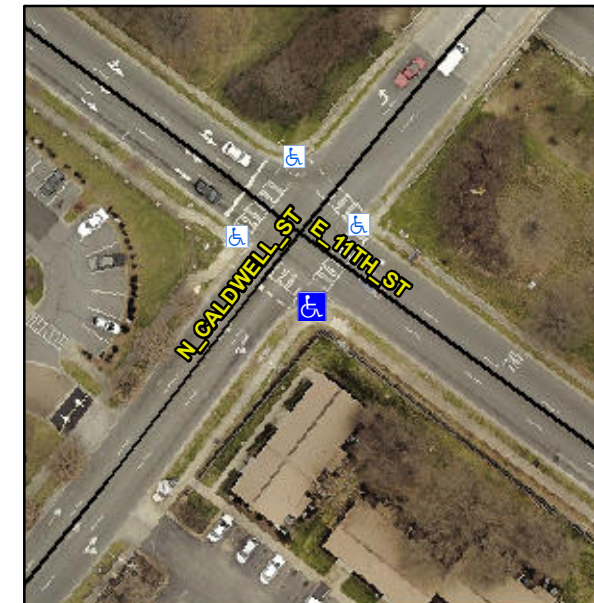
Not Found, R304.5.1, R304.5.3

Compliance	Description	Data	Compliance	Description	Data
N/A	Ramp Length (in)	100.0	Yes	Ramp Slope (%)	6.4
No	Ramp Width (in)	40.0	No	Ramp XSlope (%)	2.9
N/A	Flare Type LT	N/A	N/A	Flare Type RT	N/A
N/A	Flare Slope LT (%)	N/A	N/A	Flare Slope RT (%)	N/A
N/A	Flare Traversable LT?	N/A	N/A	Flare Traversable RT?	N/A
N/A	Landing Length (in)	N/A	N/A	DWS Provided?	N/A
N/A	Landing Width (in)	N/A	N/A	DWS Contrast?	N/A
N/A	Landing Slope (%)	N/A	N/A	DWS Length (in)	N/A
N/A	Landing X Slope (%)	N/A	N/A	DWS Full Width?	N/A
N/A	Landing Curb? (Y/N)	N/A	N/A	DWS Offset (in)	N/A
N/A	Shared Landing?	N/A			
N/A	Gutter Ponding?	N/A	N/A	Gutter Slope (%)	N/A
N/A	Gutter Lip Ht (in)	N/A	N/A	Gutter X Slope (%)	N/A
N/A	Painted X Walk1?	Yes	N/A	Painted X Walk2?	Yes
	X Walk 1 Direction	To NE		X Walk 2 Direction	To NW
N/A	X Walk 1 Width (in)	112.0	N/A	X Walk 2 Width (in)	101.0
	X Walk 1 Slope (%)	4.7		X Walk 2 Slope (%)	0.6
	X Walk 1 X Slope (%)	2.0		X Walk 2 X Slope (%)	3.9

N/A	Ramp inside XWalk1?	Yes	N/A	Ramp inside XWalk2?	Yes
	Road Slope (%)	0.7	N/A	Clear Space?	N/A
	Road X Slope (%)	4.1	N/A	Clear Space to XWalk (in)	N/A
N/A	Any Obstructions?	N/A	N/A	Storm Grate/Utility Hazard?	N/A
	Obstruction Type			Storm Grate/Utility Type	
		N/A			N/A
		Yes		Surface Condition? (G/P)	Good

Remove & Replace Curb Ramp With Two New Directional Ramps or Equivalent.

Total Cost: \$ 3200.00
