Access Compliance Report

Public Rights-of-Way

(Curb Ramps)

Intersection ID: 20143	Main Street: CANNARTI_DR	Cross Street: CEDAR_HILL_DR	Location: SE
ADA ID: C245A0C59D33	Ramp Type: PerpDiag	Initial Pass/Fail: Fail	Overall Compliance: No
		Severity Score: 60

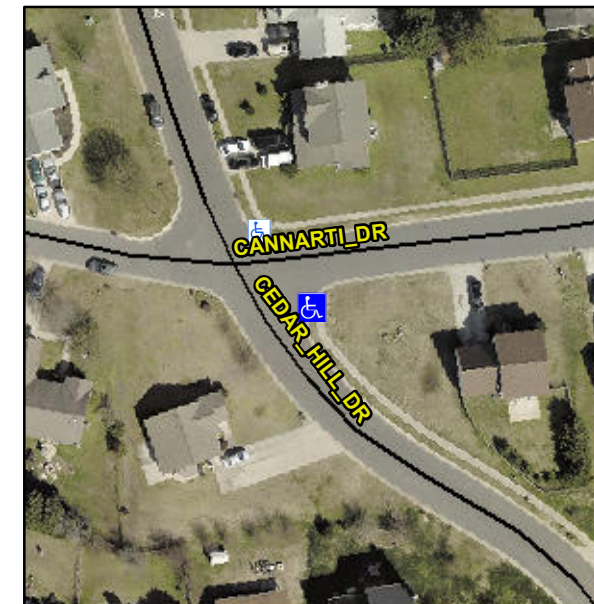
Compliance	Description	Data	Compliance	Description	Data
N/A	Ramp Length (in)	99.0	Yes	Ramp Slope (%)	7.3
No	Ramp Width (in)	30.0	No	Ramp XSlope (%)	9.0
N/A	Flare Type LT	N/A	N/A	Flare Type RT	N/A
N/A	Flare Slope LT (%)	N/A	N/A	Flare Slope RT (%)	N/A
N/A	Flare Traversable LT?	N/A	N/A	Flare Traversable RT?	N/A
N/A	Landing Length (in)	N/A	N/A	DWS Provided?	N/A
N/A	Landing Width (in)	N/A	N/A	DWS Contrast?	N/A
N/A	Landing Slope (%)	N/A	N/A	DWS Length (in)	N/A
N/A	Landing X Slope (%)	N/A	N/A	DWS Full Width?	N/A
N/A	Landing Curb? (Y/N)	N/A	N/A	DWS Offset (in)	N/A
N/A	Shared Landing?	N/A			
N/A	Gutter Ponding?	N/A	N/A	Gutter Slope (%)	N/A
N/A	Gutter Lip Ht (in)	N/A	N/A	Gutter X Slope (%)	N/A
N/A	Painted X Walk1?	No	N/A	Painted X Walk2?	No
	X Walk 1 Direction	To NW		X Walk 2 Direction	To NW
N/A	X Walk 1 Width (in)	N/A	N/A	X Walk 2 Width (in)	N/A
	X Walk 1 Slope (%)	1.6		X Walk 2 Slope (%)	0.7
	X Walk 1 X Slope (%)	1.3		X Walk 2 X Slope (%)	3.5

N/A	Ramp inside XWalk1?	N/A	N/A	Ramp inside XWalk2?	N/A
	Road Slope (%)	2.4	N/A	Clear Space?	N/A
	Road X Slope (%)	2.9	N/A	Clear Space to XWalk (in)	N/A
N/A	Any Obstructions?	N/A	N/A	Storm Grate/Utility Hazard?	N/A
	Obstruction Type			Storm Grate/Utility Type	
		N/A			N/A
			Yes	Surface Condition? (G/P)	Good

Remove & Replace Curb Ramp With Two New Directional Ramps or Equivalent.

R304.5.1, R304.5.3
