Access Compliance Report

Public Rights-of-Way

(Curb Ramps)

Intersection ID: 15175	Main Street: SOUTH_BV	Cross Street: POINDEXTER_DR	Location: W
ADA ID: C2486B6FDF95	Ramp Type: Perp	Initial Pass/Fail: Fail	Overall Compliance: No
			Severity Score: 10

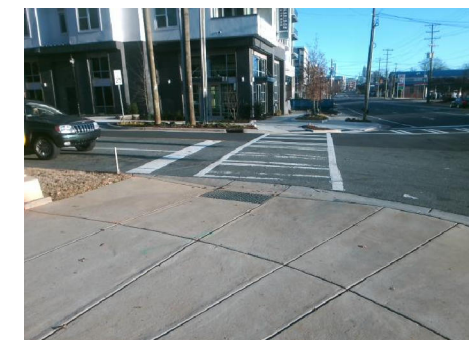
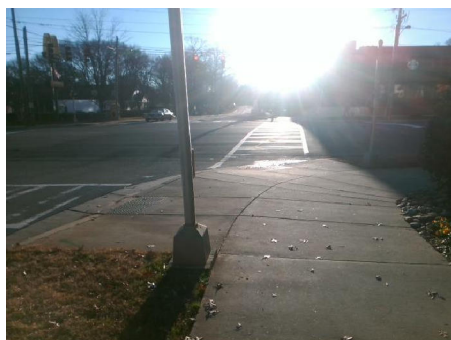
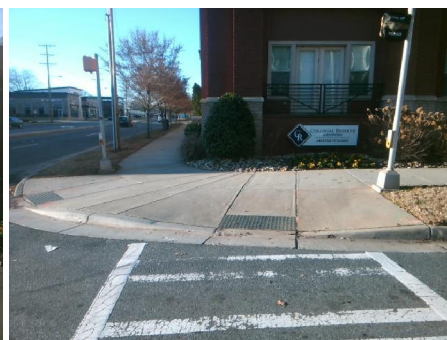
Not Found, R304.5.1, R304.5.3

Compliance	Description	Data	Compliance	Description	Data
N/A	Ramp Length (in)	96.0	Yes	Ramp Slope (%)	5.8
No	Ramp Width (in)	46.5	No	Ramp XSlope (%)	3.2
N/A	Flare Type LT	N/A	N/A	Flare Type RT	N/A
N/A	Flare Slope LT (%)	N/A	N/A	Flare Slope RT (%)	N/A
N/A	Flare Traversable LT?	N/A	N/A	Flare Traversable RT?	N/A
N/A	Landing Length (in)	N/A	N/A	DWS Provided?	N/A
N/A	Landing Width (in)	N/A	N/A	DWS Contrast?	N/A
N/A	Landing Slope (%)	N/A	N/A	DWS Length (in)	N/A
N/A	Landing X Slope (%)	N/A	N/A	DWS Full Width?	N/A
N/A	Landing Curb? (Y/N)	N/A	N/A	DWS Offset (in)	N/A
N/A	Shared Landing?	N/A			
N/A	Gutter Ponding?	N/A	N/A	Gutter Slope (%)	N/A
N/A	Gutter Lip Ht (in)	N/A	N/A	Gutter X Slope (%)	N/A
N/A	Painted X Walk1?	Yes	N/A	Painted X Walk2?	N/A
	X Walk 1 Direction	To NE		X Walk 2 Direction	N/A
N/A	X Walk 1 Width (in)	110.0	N/A	X Walk 2 Width (in)	N/A
	X Walk 1 Slope (%)	0.3		X Walk 2 Slope (%)	N/A
	X Walk 1 X Slope (%)	1.7		X Walk 2 X Slope (%)	N/A

N/A	Ramp inside XWalk1?	Yes	N/A	Ramp inside XWalk2?	N/A
	Road Slope (%)	N/A	N/A	Clear Space?	N/A
	Road X Slope (%)	N/A	N/A	Clear Space to XWalk (in)	N/A
N/A	Any Obstructions?	N/A	N/A	Storm Grate/Utility Hazard?	N/A
	Obstruction Type			Storm Grate/Utility Type	
		N/A			N/A
			Yes	Surface Condition? (G/P)	Good

Possible Solutions:

Remove & Replace Entire Ramp.
