Access Compliance Report Public Rights-of-Way (Curb Ramps)

Intersection ID: 45550	Intersection ID: 45550 Main Street: PEACHTREE_RD Cross Street: ROOK_RD							Location:	Е
		Main Street: PEACHTREE_RD							
ADA ID: C249696DA035 Ramp Type: PerpDiag			Initial P	nitial Pass/Fail: Fail Overall Compliance: No				Severity Score:	10
Codes/Mitigation Info/Possible Solution				Field Measurements/Component Compliance					
		Possible Solutions:		Compliance Description			Data Compliance Description		Data
Res Lie	-	Remove & Replace Curb Ramp	Vith	N/A	Ramp Length (in)	84.0	Yes	Ramp Slope (%)	5.0
		Two New Directional Ramps or		No	Ramp Width (in)	38.0	No	Ramp XSlope (%)	2.2
		Equivalent.		N/A	Flare Type LT	N/A	N/A	Flare Type RT	N/A
				N/A	Flare Slope LT (%)	N/A	N/A	Flare Slope RT (%)	N/A
	1			N/A	Flare Traversable LT?	N/A	N/A	Flare Traversable RT?	N/A
and the second second second	1.3			N/A	Landing Length (in)	N/A	N/A	DWS Provided?	N/A

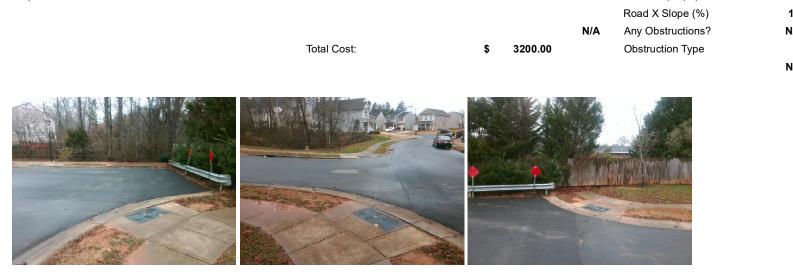
6.	New Yo	Surveyor Notes:		N/A	Landing Width (in)	N/A	N/A	DWS Contrast?	N/A
L L	MAR -	N/A		N/A	Landing Slope (%)	N/A	N/A	DWS Length (in)	N/A
				N/A	Landing X Slope (%)	N/A	N/A	DWS Full Width?	N/A
COOL C. F.	See Mar			N/A	Landing Curb? (Y/N)	N/A	N/A	DWS Offset (in)	N/A
	Set. De			N/A	Shared Landing?	N/A			
	· ···································	PROW/ADA:		N/A	Gutter Ponding?	N/A	N/A	Gutter Slope (%)	N/A
		Not Found, R304.5.1, R304.5.3		N/A	Gutter Lip Ht (in)	N/A	N/A	Gutter X Slope (%)	N/A
				N/A	Painted X Walk1?	No	N/A	Painted X Walk2?	No
					X Walk 1 Direction	To N		X Walk 2 Direction	To SW
				N/A	X Walk 1 Width (in)	N/A	N/A	X Walk 2 Width (in)	N/A
Street 1 Name	ROOK RD	_			X Walk 1 Slope (%)	1.9		X Walk 2 Slope (%)	0.2
Stop Condition-Street 2	None				X Walk 1 X Slope (%)	1.6		X Walk 2 X Slope (%)	0.5
Street 2 Name	PEACHTREE RD			N/A	Ramp inside XWalk1?	N/A	N/A	Ramp inside XWalk2?	N/A
Stop Condition-Street 1	None				Road Slope (%)	1.7	N/A	Clear Space?	N/A

Road X Slope (%)	1.0	N/A	Clear Space to XWalk (in)	N/A
				N/A	Any Obstructions?	N/A	N/A	Storm Grate/Utility Hazard?	N/A
		Total Cost: \$ 33	200.00		Obstruction Type			Storm Grate/Utility Type	
						N/A			N/A

Yes Surface Condition? (G/P) Good
