Access Compliance Report

Public Rights-of-Way

(Curb Ramps)

| Intersection ID: 10024493 | Main Street: CROWNPOINT_EXECUTIVE_DR | Cross Street: N/A | Location: NW |

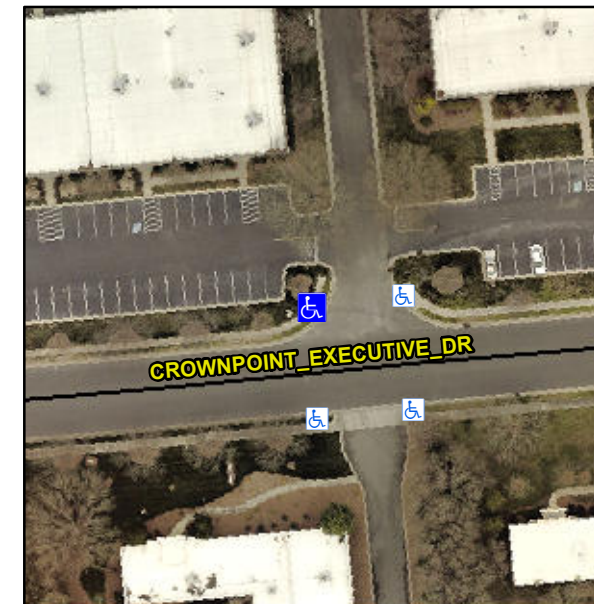
| ADA ID: C24B671F8FC3 | Ramp Type: PerpDiag | Initial Pass/Fail: Fail | Overall Compliance: No |

Not Found, R304.5.1

| Compliance | Description | Data | Compliance | Description | Data |
|---|---|---|---|---|---|
| No | Ramp Width (in) | 45.0 | Yes | Ramp XSlope (%) | 0.8 |

Remove & Replace Curb Ramp With Two New Directional Ramps or Equivalent.
