## Access Compliance Report Public Rights-of-Way (Curb Ramps)

Intersection ID: 3098Main Street:STEWART\_SPRING\_LNCross Street:WALDEN\_RIDGE\_DRLocation:NADA ID: C251A027E90DRamp Type:PerpInitial Pass/Fail:FailOverall Compliance:NoSeverity Score:37.5

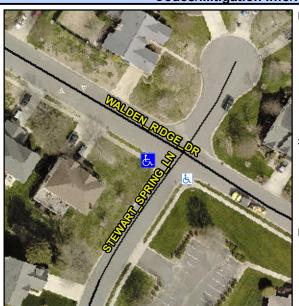
Compliance Description Data Compliance Description Da					
N/A	Ramp Length (in)	26.0	No	Ramp Slope (%)	10.4
Yes	Ramp Width (in)	48.0	No	Ramp XSlope (%)	7.9
N/A	Flare Type LT	N/A	N/A	Flare Type RT	N/A
N/A	Flare Slope LT (%)	N/A	N/A	Flare Slope RT (%)	N/A
N/A	Flare Traversable LT?	N/A	N/A	Flare Traversable RT?	N/A
N/A	Landing Length (in)	N/A	N/A	DWS Provided?	N/A
N/A	Landing Width (in)	N/A	N/A	DWS Contrast?	N/A
N/A	Landing Slope (%)	N/A	N/A	DWS Length (in)	N/A
N/A	Landing X Slope (%)	N/A	N/A	DWS Full Width?	N/A
N/A	Landing Curb? (Y/N)	N/A	N/A	DWS Offset (in)	N/A
N/A	Shared Landing?	N/A			
N/A	Gutter Ponding?	N/A	N/A	Gutter Slope (%)	N/A
N/A	Gutter Lip Ht (in)	N/A	N/A	Gutter X Slope (%)	N/A
N/A	Painted X Walk1?	No	N/A	Painted X Walk2?	N/A
	X Walk 1 Direction	To SE		X Walk 2 Direction	N/A
N/A	X Walk 1 Width (in)	N/A	N/A	X Walk 2 Width (in)	N/A
	X Walk 1 Slope (%)	4.0		X Walk 2 Slope (%)	N/A
	X Walk 1 X Slope (%)	4.4		X Walk 2 X Slope (%)	N/A

N/A	Ramp inside XWalk1?	N/A	N/A	Ramp inside XWalk2?	N/A
	Road Slope (%)	N/A	N/A	Clear Space?	N/A
	Road X Slope (%)	N/A	N/A	Clear Space to XWalk (in)	N/A
N/A	Any Obstructions?	N/A	N/A	Storm Grate/Utility Hazard?	N/A
	Obstruction Type		l	Storm Grate/Utility Type	
		N/A			N/A
			Yes	Surface Condition? (G/P)	Good

Possible Solutions:					
Remove & Replace Entire Ramp.					
Surveyor Notes:					
•					
N/A					
PROW/ADA:					
Not Found, R304.2.2, R304.5.3					
Not i Gaila, 1304.2.2, 1304.3.3
