## **Access Compliance Report Public Rights-of-Way** (Curb Ramps)

Intersection ID: N/A Main Street: S BREVARD ST Cross Street: E 3RD ST Location:

Initial Pass/Fail: Fail **Overall Compliance: No ADA ID: C25E1E0C829E** Ramp Type: Perp Severity Score: 13.75

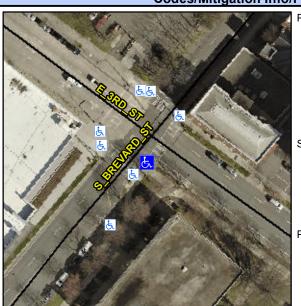
Data No N/A Ramp Length (in) 72.0 Ramp Slope (%) 9.9 No Ramp XSlope (%) Yes Ramp Width (in) 48.0 4.9 N/A N/A Flare Type LT N/A Flare Type RT N/A N/A N/A N/A Flare Slope RT (%) Flare Slope LT (%) N/A N/A Flare Traversable LT? Nο N/A Flare Traversable RT? No N/A N/A N/A **DWS Provided?** N/A Landing Length (in) N/A Landing Width (in) N/A N/A **DWS Contrast?** N/A N/A N/A N/A Landing Slope (%) DWS Length (in) N/A N/A Landing X Slope (%) N/A N/A DWS Full Width? N/A N/A Landing Curb? (Y/N) N/A N/A DWS Offset (in) N/A N/A N/A Shared Landing? N/A **Gutter Ponding?** N/A N/A Gutter Slope (%) N/A N/A Gutter Lip Ht (in) N/A N/A Gutter X Slope (%) N/A N/A Painted X Walk1? Yes N/A Painted X Walk2? N/A X Walk 1 Direction To NE X Walk 2 Direction N/A N/A 111.0 N/A X Walk 1 Width (in) X Walk 2 Width (in) N/A X Walk 1 Slope (%) 0.2 X Walk 2 Slope (%) N/A X Walk 1 X Slope (%) 1.8 X Walk 2 X Slope (%) N/A N/A N/A Ramp inside XWalk2? Ramp inside XWalk1? Yes N/A Road Slope (%) N/A N/A Clear Space? N/A Road X Slope (%) N/A N/A Clear Space to XWalk (in) N/A N/A N/A Any Obstructions? N/A Storm Grate/Utility Hazard? N/A **Obstruction Type** Storm Grate/Utility Type N/A N/A Yes Surface Condition? (G/P) Good

Possible Solutions: Remove & Replace Entire Ramp. Surveyor Notes: N/A PROW/ADA: Not Found, R304.2.2, R304.5.3
