Access Compliance Report

Public Rights-of-Way

(Curb Ramps)

Intersection ID: 14980	Main Street: DILWORTH_RD_EAST	Cross Street: EAST_BV	Location: SW
ADA ID: C266D64637C6	Ramp Type: Perp	Initial Pass/Fail: Fail	Overall Compliance: No
Severity Score: 12.5			
Codes/Mitigation Info/Possible Solution		Field Measurements/Component Compliance

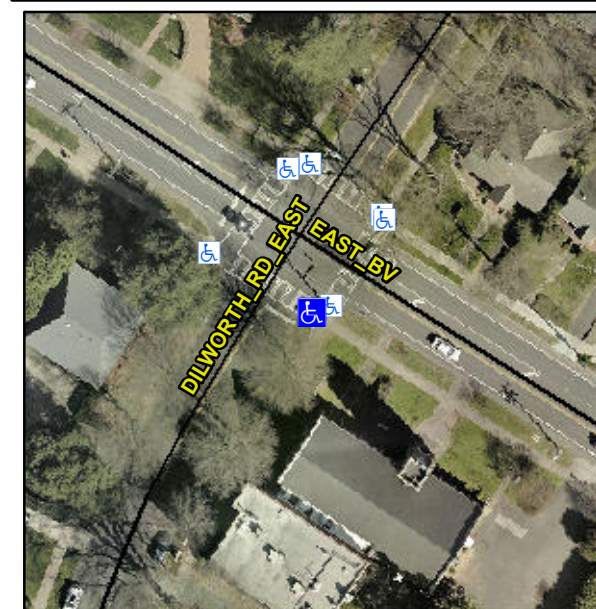
Not Found, R304.2.2

Compliance	Description	Data	Compliance	Description	Data
N/A	Ramp Length (in)	88.0	No	Ramp Slope (%)	9.3
Yes	Ramp Width (in)	73.0	Yes	Ramp XSlope (%)	0.1
N/A	Flare Type LT	N/A	N/A	Flare Type RT	N/A
N/A	Flare Slope LT (%)	N/A	N/A	Flare Slope RT (%)	N/A
N/A	Flare Traversable LT?	N/A	N/A	Flare Traversable RT?	N/A
N/A	Landing Length (in)	N/A	N/A	DWS Provided?	N/A
N/A	Landing Width (in)	N/A	N/A	DWS Contrast?	N/A
N/A	Landing Slope (%)	N/A	N/A	DWS Length (in)	N/A
N/A	Landing X Slope (%)	N/A	N/A	DWS Full Width?	N/A
N/A	Landing Curb? (Y/N)	N/A	N/A	DWS Offset (in)	N/A
N/A	Shared Landing?	N/A			
N/A	Gutter Ponding?	N/A	N/A	Gutter Slope (%)	N/A
N/A	Gutter Lip Ht (in)	N/A	N/A	Gutter X Slope (%)	N/A
N/A	Painted X Walk1?	Yes	N/A	Painted X Walk2?	N/A
	X Walk 1 Direction	To NW		X Walk 2 Direction	N/A
N/A	X Walk 1 Width (in)	110.0	N/A	X Walk 2 Width (in)	N/A
	X Walk 1 Slope (%)	6.8		X Walk 2 Slope (%)	N/A
	X Walk 1 X Slope (%)	2.5		X Walk 2 X Slope (%)	N/A

N/A	Ramp inside XWalk1?	Yes	N/A	Ramp inside XWalk2?	N/A
	Road Slope (%)	N/A	N/A	Clear Space?	N/A
	Road X Slope (%)	N/A	N/A	Clear Space to XWalk (in)	N/A
N/A	Any Obstructions?	N/A	N/A	Storm Grate/Utility Hazard?	N/A
	Obstruction Type			Storm Grate/Utility Type	
		N/A			N/A
		Yes		Surface Condition? (G/P)	Good

Remove & Replace Entire Ramp.

Total Cost: \$ 1850.00
