## **Access Compliance Report Public Rights-of-Way** (Curb Ramps)

Intersection ID: 8802 Main Street: E W T HARRIS BV Cross Street: ST\_JOHNS\_CHURCH\_RD Location: NW **ADA ID: C2721AFA465B** Ramp Type: BlendTrans1 Initial Pass/Fail: Fail **Overall Compliance: No Severity Score:** 1.25

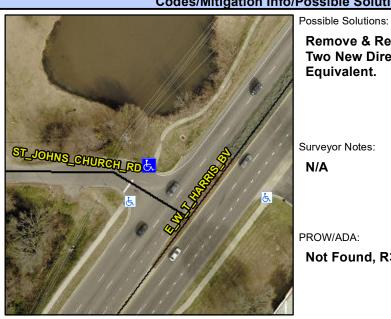
Not Found, R304.5.3

Field Measurements/Component Compliance						
Compliance Description Data		Comp	liance Description	Data		
N/A	Ramp Length (in)	118.5	Yes	BlendTrans Slope (%)	0.9	
Yes	Ramp Width (in)	72.0	No	BlendTrans XSlope (%)	3.7	
N/A	Flare Type LT	N/A	N/A	Flare Type RT	N/A	
N/A	Flare Slope LT (%)	N/A	N/A	Flare Slope RT (%)	N/A	
N/A	Flare Traversable LT?	N/A	N/A	Flare Traversable RT?	N/A	
N/A	Landing Length (in)	N/A	N/A	DWS Provided?	N/A	
N/A	Landing Width (in)	N/A	N/A	DWS Contrast?	N/A	
N/A	Landing Slope (%)	N/A	N/A	DWS Length (in)	N/A	
N/A	Landing X Slope (%)	N/A	N/A	DWS Full Width?	N/A	
N/A	Landing Curb? (Y/N)	N/A	N/A	DWS Offset (in)	N/A	
N/A	Shared Landing?	N/A				
N/A	Gutter Ponding?	N/A	N/A	Gutter Slope (%)	N/A	
N/A	Gutter Lip Ht (in)	N/A	N/A	Gutter X Slope (%)	N/A	
N/A	Painted X Walk1?	No	N/A	Painted X Walk2?	N/A	
	X Walk 1 Direction	To SW		X Walk 2 Direction	N/A	
	X Walk 1 Width (in)	N/A		X Walk 2 Width (in)	N/A

X Walk 1 Slope (%)	1.8		X Walk 2 Slope (%)	N/A	
	X Walk 1 X Slope (%)	4.7		X Walk 2 X Slope (%)	N/A	
N/A	Ramp inside XWalk1?	N/A	N/A	Ramp inside XWalk2?	N/A	
	Road Slope (%)	4.7		Clear Space?	N/A	
	Road X Slope (%)	1.8	N/A	Clear Space to XWalk (in)	N/A	
N/A	Any Obstructions?	N/A	N/A	Storm Grate/Utility Hazard?	N/A	
	Obstruction Type			Storm Grate/Utility Type		
		N/A			N/A	
			Yes	Surface Condition? (G/P)	Good	
	/A DECEMBER OF THE PARTY OF THE		No	Curb Slope (%)	14.0

**Remove & Replace Curb Ramp With** Two New Directional Ramps or Equivalent.
