# Access Compliance Report

## Public Rights-of-Way

### (Curb Ramps)

Intersection ID: 44006	Main Street: DEMAINE_DR	Cross Street: ELROSE_PL	Location:	N
ADA ID: C2728329FE7D	Ramp Type: PerpDiag	Initial Pass/Fail: Fail	Overall Compliance: No	Severity Score: 10

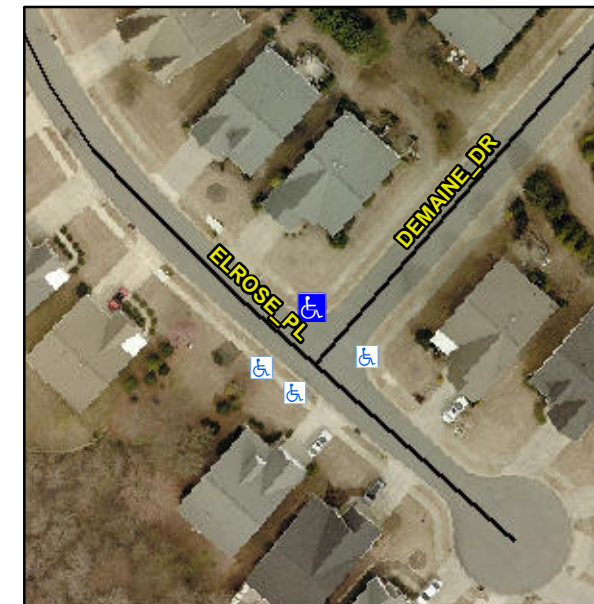
**Not Found, R304.5.1, R304.5.3**

Compliance	Description	Data	Compliance	Description	Data
N/A	Ramp Length (in)	48.0	Yes	Ramp Slope (%)	5.5
No	Ramp Width (in)	44.0	No	Ramp XSlope (%)	4.3
N/A	Flare Type LT	N/A	N/A	Flare Type RT	N/A
N/A	Flare Slope LT (%)	N/A	N/A	Flare Slope RT (%)	N/A
N/A	Flare Traversable LT?	N/A	N/A	Flare Traversable RT?	N/A
N/A	Landing Length (in)	N/A	N/A	DWS Provided?	N/A
N/A	Landing Width (in)	N/A	N/A	DWS Contrast?	N/A
N/A	Landing Slope (%)	N/A	N/A	DWS Length (in)	N/A
N/A	Landing X Slope (%)	N/A	N/A	DWS Full Width?	N/A
N/A	Landing Curb? (Y/N)	N/A	N/A	DWS Offset (in)	N/A
N/A	Shared Landing?	N/A			
N/A	Gutter Ponding?	N/A	N/A	Gutter Slope (%)	N/A
N/A	Gutter Lip Ht (in)	N/A	N/A	Gutter X Slope (%)	N/A
N/A	Painted X Walk1?	No	N/A	Painted X Walk2?	No
	X Walk 1 Direction	To SW		X Walk 2 Direction	To SE
N/A	X Walk 1 Width (in)	N/A	N/A	X Walk 2 Width (in)	N/A
	X Walk 1 Slope (%)	4.0		X Walk 2 Slope (%)	1.4
	X Walk 1 X Slope (%)	2.8		X Walk 2 X Slope (%)	4.2

N/A	Ramp inside XWalk1?	N/A	N/A	Ramp inside XWalk2?	N/A
	Road Slope (%)	5.1	N/A	Clear Space?	N/A
	Road X Slope (%)	2.9	N/A	Clear Space to XWalk (in)	N/A
N/A	Any Obstructions?	N/A	N/A	Storm Grate/Utility Hazard?	N/A
	Obstruction Type			Storm Grate/Utility Type	
		N/A			N/A
			Yes	Surface Condition? (G/P)	Good

**Remove & Replace Curb Ramp With Two New Directional Ramps or Equivalent.**
