Access Compliance Report

Public Rights-of-Way

(Curb Ramps)

Intersection ID: 11452	Main Street: E_16TH_ST	Cross Street: PARKWOOD_AV	Location: W
ADA ID: C275BB33E91D	Ramp Type: Perp	Initial Pass/Fail: Fail	Overall Compliance: No
Severity Score: 22.5			
Codes/Mitigation Info/Possible Solution		Field Measurements/Component Compliance

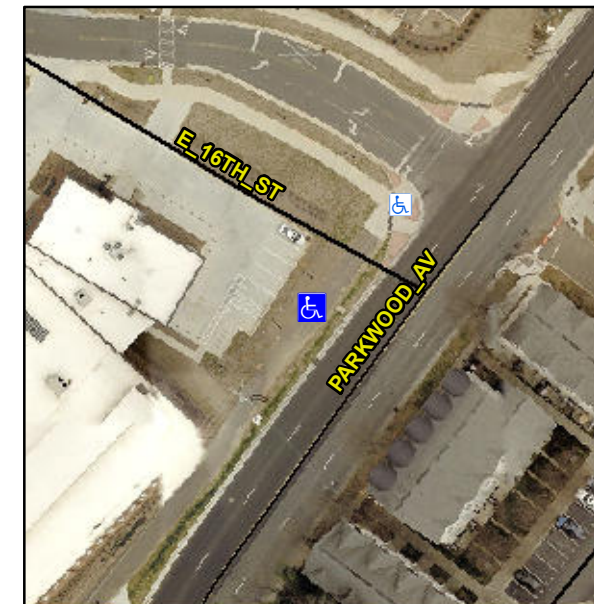
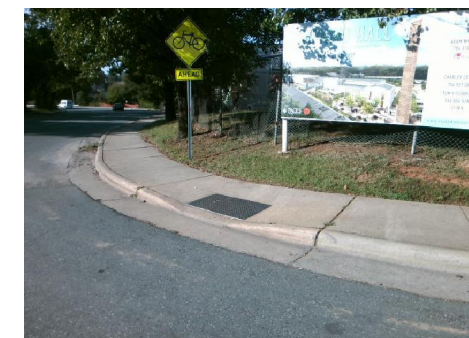
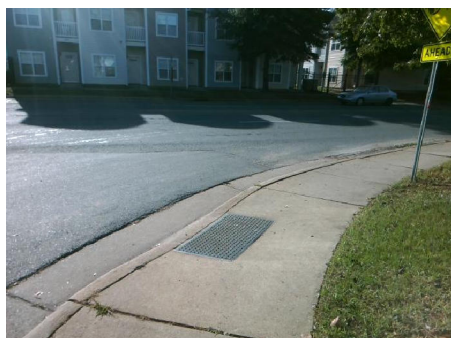
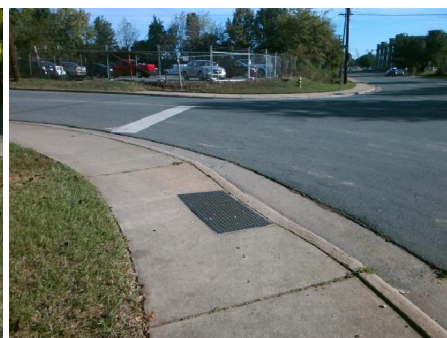
Not Found, R304.5.1, R304.2.2, R304.5.3

Compliance	Description	Data	Compliance	Description	Data
N/A	Ramp Length (in)	59.0	No	Ramp Slope (%)	9.1
No	Ramp Width (in)	43.0	No	Ramp XSlope (%)	3.1
N/A	Flare Type LT	N/A	N/A	Flare Type RT	N/A
N/A	Flare Slope LT (%)	N/A	N/A	Flare Slope RT (%)	N/A
N/A	Flare Traversable LT?	N/A	N/A	Flare Traversable RT?	N/A
N/A	Landing Length (in)	N/A	N/A	DWS Provided?	N/A
N/A	Landing Width (in)	N/A	N/A	DWS Contrast?	N/A
N/A	Landing Slope (%)	N/A	N/A	DWS Length (in)	N/A
N/A	Landing X Slope (%)	N/A	N/A	DWS Full Width?	N/A
N/A	Landing Curb? (Y/N)	N/A	N/A	DWS Offset (in)	N/A
N/A	Shared Landing?	N/A			
N/A	Gutter Ponding?	N/A	N/A	Gutter Slope (%)	N/A
N/A	Gutter Lip Ht (in)	1.0	N/A	Gutter X Slope (%)	N/A
N/A	Painted X Walk1?	No	N/A	Painted X Walk2?	N/A
	X Walk 1 Direction	To NE		X Walk 2 Direction	N/A
N/A	X Walk 1 Width (in)	N/A	N/A	X Walk 2 Width (in)	N/A
	X Walk 1 Slope (%)	1.4		X Walk 2 Slope (%)	N/A
	X Walk 1 X Slope (%)	1.1		X Walk 2 X Slope (%)	N/A

N/A	Ramp inside XWalk1?	N/A	N/A	Ramp inside XWalk2?	N/A
	Road Slope (%)	N/A	N/A	Clear Space?	N/A
	Road X Slope (%)	N/A	N/A	Clear Space to XWalk (in)	N/A
N/A	Any Obstructions?	N/A	N/A	Storm Grate/Utility Hazard?	N/A
	Obstruction Type			Storm Grate/Utility Type	
		N/A			N/A
			Yes	Surface Condition? (G/P)	Good

Possible Solutions:

Remove & Replace Entire Ramp.
