Access Compliance Report

Public Rights-of-Way

(Curb Ramps)

Intersection ID: 11740	Main Street: BELMONT_AV	Cross Street: N_CALDWELL_ST	Location: SE
ADA ID: C27E26E99BDC	Ramp Type: PerpDiag	Initial Pass/Fail: Fail	Overall Compliance: No
Severity Score: 22.5			
Codes/Mitigation Info/Possible Solution		Field Measurements/Component Compliance

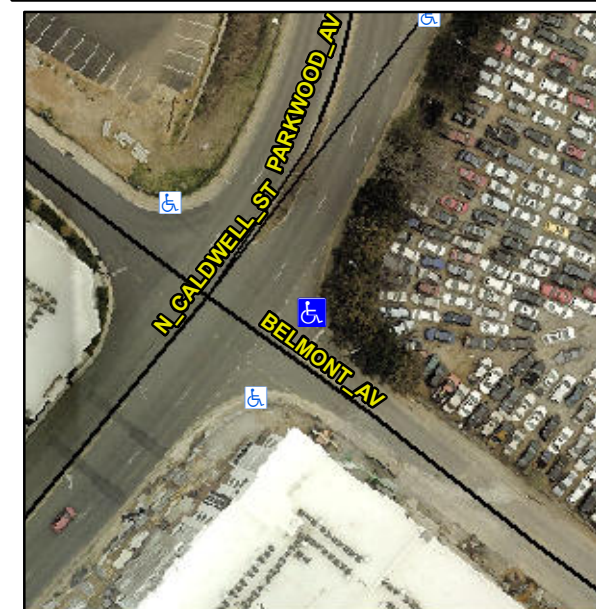
Not Found, R304.5.1, R304.2.2, R304.5.3

Compliance	Description	Data	Compliance	Description	Data
N/A	Ramp Length (in)	51.0	No	Ramp Slope (%)	9.2
No	Ramp Width (in)	39.0	No	Ramp XSlope (%)	3.4
N/A	Flare Type LT	N/A	N/A	Flare Type RT	N/A
N/A	Flare Slope LT (%)	N/A	N/A	Flare Slope RT (%)	N/A
N/A	Flare Traversable LT?	N/A	N/A	Flare Traversable RT?	N/A
N/A	Landing Length (in)	N/A	N/A	DWS Provided?	N/A
N/A	Landing Width (in)	N/A	N/A	DWS Contrast?	N/A
N/A	Landing Slope (%)	N/A	N/A	DWS Length (in)	N/A
N/A	Landing X Slope (%)	N/A	N/A	DWS Full Width?	N/A
N/A	Landing Curb? (Y/N)	N/A	N/A	DWS Offset (in)	N/A
N/A	Shared Landing?	N/A			
N/A	Gutter Ponding?	N/A	N/A	Gutter Slope (%)	N/A
N/A	Gutter Lip Ht (in)	1.5	N/A	Gutter X Slope (%)	N/A
N/A	Painted X Walk1?	No	N/A	Painted X Walk2?	No
	X Walk 1 Direction	To NW		X Walk 2 Direction	To SW
N/A	X Walk 1 Width (in)	N/A	N/A	X Walk 2 Width (in)	N/A
	X Walk 1 Slope (%)	0.6		X Walk 2 Slope (%)	4.2
	X Walk 1 X Slope (%)	5.3		X Walk 2 X Slope (%)	2.3

N/A	Ramp inside XWalk1?	N/A	N/A	Ramp inside XWalk2?	N/A
	Road Slope (%)	2.3	N/A	Clear Space?	N/A
	Road X Slope (%)	3.1	N/A	Clear Space to XWalk (in)	N/A
N/A	Any Obstructions?	N/A	N/A	Storm Grate/Utility Hazard?	N/A
	Obstruction Type			Storm Grate/Utility Type	
		N/A			N/A
			Yes	Surface Condition? (G/P)	Good

Remove & Replace Curb Ramp With Two New Directional Ramps or Equivalent.
