# Access Compliance Report

## Public Rights-of-Way

### (Curb Ramps)

Intersection ID: 20364	Main Street: MEADOW_STONE_CT	Cross Street: STEELECHASE_DR	Location: S
ADA ID: C280E24048D4	Ramp Type: PerpDiag	Initial Pass/Fail: Fail	Overall Compliance: No
		Severity Score: 12.5

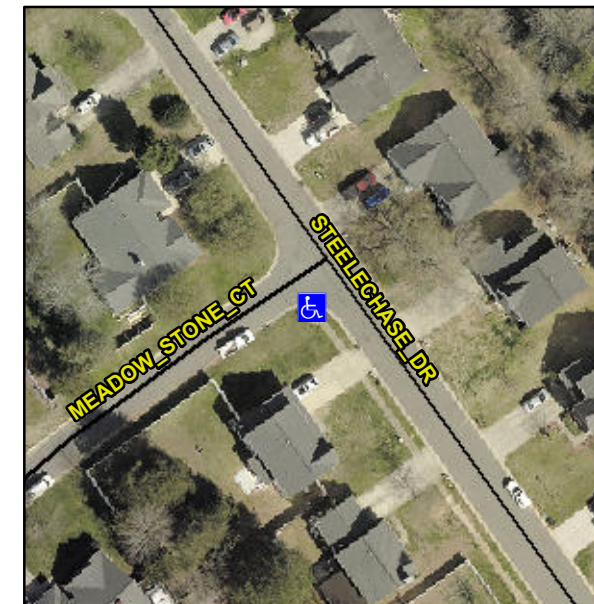
Compliance	Description	Data	Compliance	Description	Data
N/A	Ramp Length (in)	48.0	Yes	Ramp Slope (%)	6.4
Yes	Ramp Width (in)	48.0	No	Ramp XSlope (%)	6.9
N/A	Flare Type LT	N/A	N/A	Flare Type RT	N/A
N/A	Flare Slope LT (%)	N/A	N/A	Flare Slope RT (%)	N/A
N/A	Flare Traversable LT?	N/A	N/A	Flare Traversable RT?	N/A
N/A	Landing Length (in)	N/A	N/A	DWS Provided?	N/A
N/A	Landing Width (in)	N/A	N/A	DWS Contrast?	N/A
N/A	Landing Slope (%)	N/A	N/A	DWS Length (in)	N/A
N/A	Landing X Slope (%)	N/A	N/A	DWS Full Width?	N/A
N/A	Landing Curb? (Y/N)	N/A	N/A	DWS Offset (in)	N/A
N/A	Shared Landing?	N/A			
N/A	Gutter Ponding?	N/A	N/A	Gutter Slope (%)	N/A
N/A	Gutter Lip Ht (in)	N/A	N/A	Gutter X Slope (%)	N/A
N/A	Painted X Walk1?	No	N/A	Painted X Walk2?	No
	X Walk 1 Direction	To NE		X Walk 2 Direction	To NW
N/A	X Walk 1 Width (in)	N/A	N/A	X Walk 2 Width (in)	N/A
	X Walk 1 Slope (%)	2.3		X Walk 2 Slope (%)	1.6
	X Walk 1 X Slope (%)	0.8		X Walk 2 X Slope (%)	2.8

N/A	Ramp inside XWalk1?	N/A	N/A	Ramp inside XWalk2?	N/A
	Road Slope (%)	2.6	N/A	Clear Space?	N/A
	Road X Slope (%)	1.9	N/A	Clear Space to XWalk (in)	N/A
N/A	Any Obstructions?	N/A	N/A	Storm Grate/Utility Hazard?	N/A
	Obstruction Type			Storm Grate/Utility Type	
		N/A			N/A
		Yes		Surface Condition? (G/P)	Good

Possible Solutions:

**Remove & Replace Curb Ramp With Two New Directional Ramps or Equivalent.**

**R304.5.3**
