Access Compliance Report

Public Rights-of-Way

(Curb Ramps)

Intersection ID: 52716	Main Street: AGAVA_LN	Cross Street: MAIDENHAIR_CT	Location: NW
ADA ID: C2924C2149A8	Ramp Type: Perp	Initial Pass/Fail: Pass	Overall Compliance: No
Severity Score: 4			
Codes/Mitigation Info/Possible Solution		Field Measurements/Component Compliance

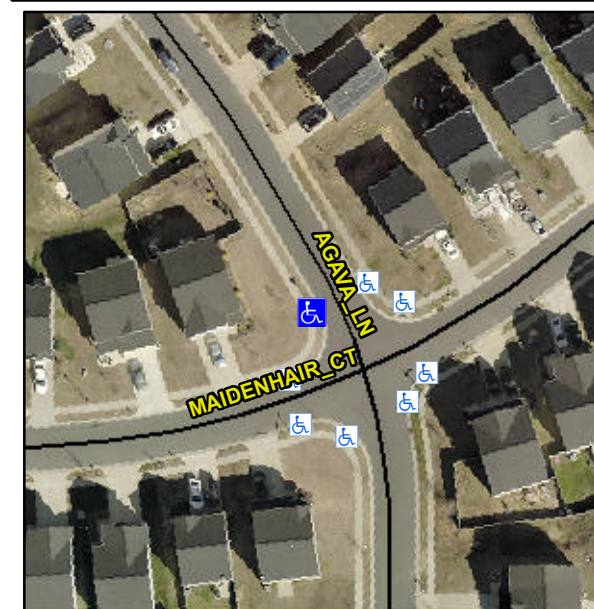
Not Found, R304.2.1, R302.7

Compliance	Description	Data	Compliance	Description	Data
N/A	Ramp Length (in)	48.0	Yes	Ramp Slope (%)	6.2
Yes	Ramp Width (in)	48.0	Yes	Ramp XSlope (%)	1.6
N/A	Flare Type LT	Sloped	N/A	Flare Type RT	N/A
N/A	Flare Slope LT (%)	4.7	N/A	Flare Slope RT (%)	2.6
N/A	Flare Traversable LT?	No	N/A	Flare Traversable RT?	No
No	Landing Length (in)	47.5	Yes	DWS Provided?	Yes
No	Landing Width (in)	45.0	Yes	DWS Contrast?	Yes
Yes	Landing Slope (%)	1.0	Yes	DWS Length (in)	24.0
Yes	Landing X Slope (%)	1.1	Yes	DWS Full Width?	Yes
N/A	Landing Curb? (Y/N)	No	Yes	DWS Offset (in)	1.8
N/A	Shared Landing?	No			
No	Gutter Ponding?	Yes	Yes	Gutter Slope (%)	4.1
Yes	Gutter Lip Ht (in)	0.0	Yes	Gutter X Slope (%)	1.4
N/A	Painted X Walk1?	No	N/A	Painted X Walk2?	N/A
	X Walk 1 Direction	To E		X Walk 2 Direction	N/A
N/A	X Walk 1 Width (in)	N/A	N/A	X Walk 2 Width (in)	N/A
	X Walk 1 Slope (%)	2.1		X Walk 2 Slope (%)	N/A
	X Walk 1 X Slope (%)	2.5		X Walk 2 X Slope (%)	N/A

N/A	Ramp inside XWalk1?	N/A	N/A	Ramp inside XWalk2?	N/A
	Road Slope (%)	N/A	N/A	Clear Space?	Yes
	Road X Slope (%)	N/A	N/A	Clear Space to XWalk (in)	N/A
Yes	Any Obstructions?	No	Yes	Storm Grate/Utility Hazard?	No
	Obstruction Type			Storm Grate/Utility Type	
		N/A			N/A
			Yes	Surface Condition? (G/P)	Good

Possible Solutions:

Remove & Replace Entire Ramp.
