Access Compliance Report

Public Rights-of-Way

(Curb Ramps)

Intersection ID: 30677	Main Street: DIXIE_HILLS_DR	Cross Street: MARVIN_RD	Location:	N
ADA ID: C2958F3C1436	Ramp Type: BlendTrans2	Initial Pass/Fail: Fail	Overall Compliance: No	Severity Score: 12.5
Codes/Mitigation Info/Possible Solution		Field Measurements/Component Compliance

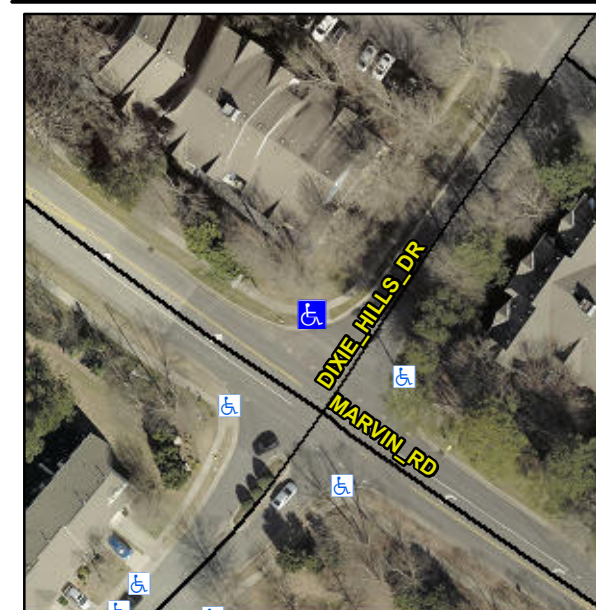
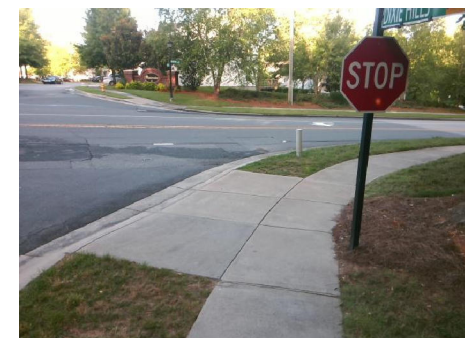
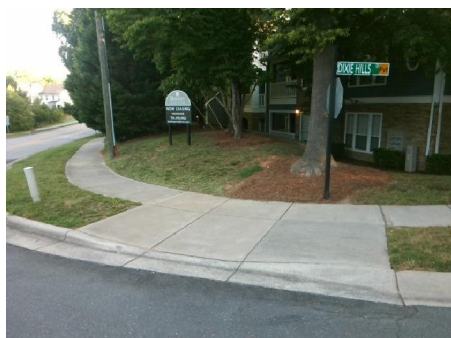
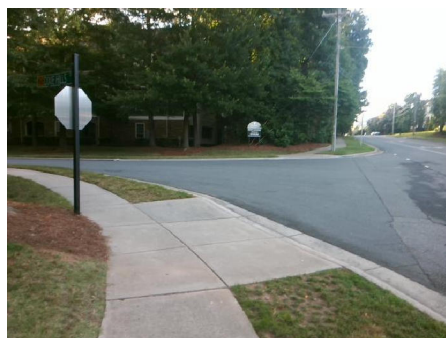
Not Found, R304.5.3

Compliance	Description	Data	Compliance	Description	Data
N/A	Ramp Length (in)	114.0	Yes	BlendTrans Slope (%)	3.5
Yes	Ramp Width (in)	56.0	No	BlendTrans XSlope (%)	6.1
N/A	Flare Type LT	N/A	N/A	Flare Type RT	N/A
N/A	Flare Slope LT (%)	N/A	N/A	Flare Slope RT (%)	N/A
N/A	Flare Traversable LT?	N/A	N/A	Flare Traversable RT?	N/A
N/A	Landing Length (in)	N/A	N/A	DWS Provided?	N/A
N/A	Landing Width (in)	N/A	N/A	DWS Contrast?	N/A
N/A	Landing Slope (%)	N/A	N/A	DWS Length (in)	N/A
N/A	Landing X Slope (%)	N/A	N/A	DWS Full Width?	N/A
N/A	Landing Curb? (Y/N)	N/A	N/A	DWS Offset (in)	N/A
N/A	Shared Landing?	N/A			
N/A	Gutter Ponding?	N/A	N/A	Gutter Slope (%)	N/A
N/A	Gutter Lip Ht (in)	N/A	N/A	Gutter X Slope (%)	N/A
N/A	Painted X Walk1?	No	N/A	Painted X Walk2?	No
	X Walk 1 Direction	To SW		X Walk 2 Direction	To SE
	X Walk 1 Width (in)	N/A		X Walk 2 Width (in)	N/A
	X Walk 1 Slope (%)	0.0		X Walk 2 Slope (%)	7.7
	X Walk 1 X Slope (%)	8.2		X Walk 2 X Slope (%)	0.6

N/A	Ramp inside XWalk1?	N/A	N/A	Ramp inside XWalk2?	N/A
	Road Slope (%)	4.5		Clear Space?	N/A
	Road X Slope (%)	6.2	N/A	Clear Space to XWalk (in)	N/A
N/A	Any Obstructions?	N/A	N/A	Storm Grate/Utility Hazard?	N/A
	Obstruction Type			Storm Grate/Utility Type	
		N/A			N/A
			Yes	Surface Condition? (G/P)	Good
			No	Curb Slope (%)	6.2

Remove & Replace Curb Ramp With Two New Directional Ramps or Equivalent.
